LOG HOUSE PERFORMANCE IN THE 2016 KAIKOURA EARTHQUAKE

Andy Buchanan¹ and Daniel Moroder²

This paper describes the performance of log houses in the 2016 Kaikoura earthquake. Most of these houses are in the Mt Lyford village 45 km south-east of Kaikoura.

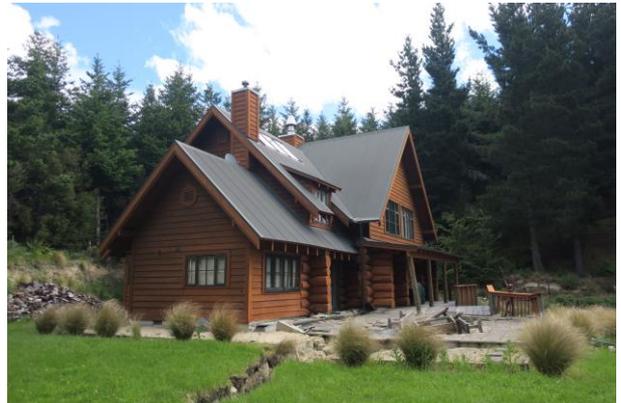
Figure 10: Two storey traditional log house with geotechnical damage

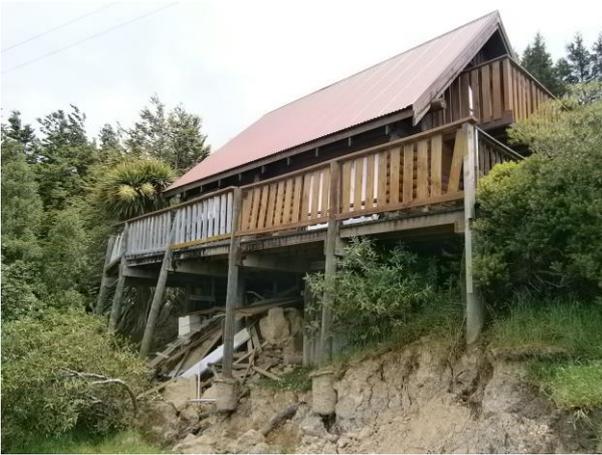
Figure 11: Two storey log house on slope with pole foundation with slope stability failure

Many of the houses had geotechnical damage to the surrounding ground. A few houses lost support due to slope stability issues, as shown by the loss of support to the deck in Figure 11.

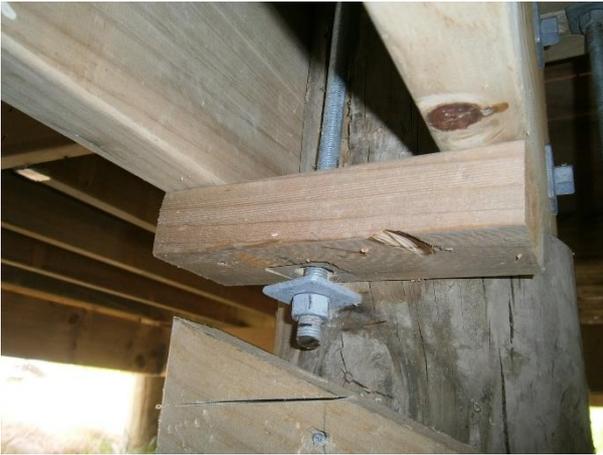
For houses on raised timber floors, the most typical detail is for the vertical rods to run full height from the top of the top log to the underside of the foundations. The bottom end of the rods is often anchored between double timber bearers as shown in Figure 14.

Figure 14: Typical anchorage with a timber block between floor bearers

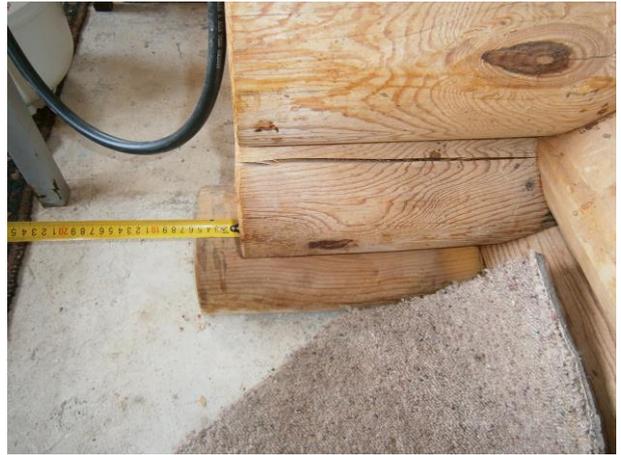
Figure 16: Sliding at the top of the bottom half-log

In a few houses with poor anchorage, the whole house slid horizontally on the foundations, by up to 100mm. Figure 15 shows local sliding of the house in Figure 3. Sometimes the sliding was at the top of the bottom half-log as shown in Figure 16. In a few exceptional cases, objects were trapped under the bottom log, showing that there had been considerable upward movement of the whole wall for a few moments during the earthquake as shown in Figure 17.

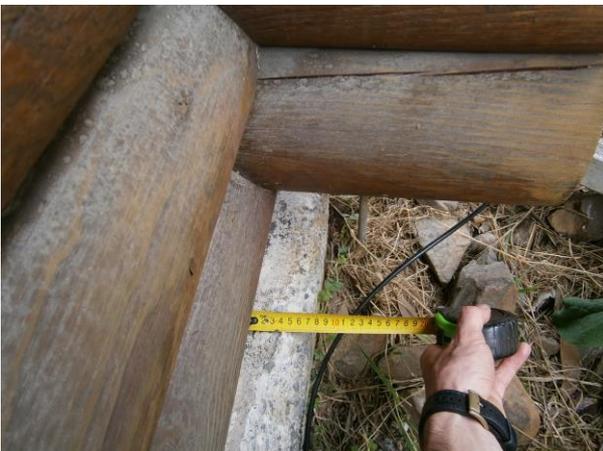
Figure 15: Horizontal sliding of the house

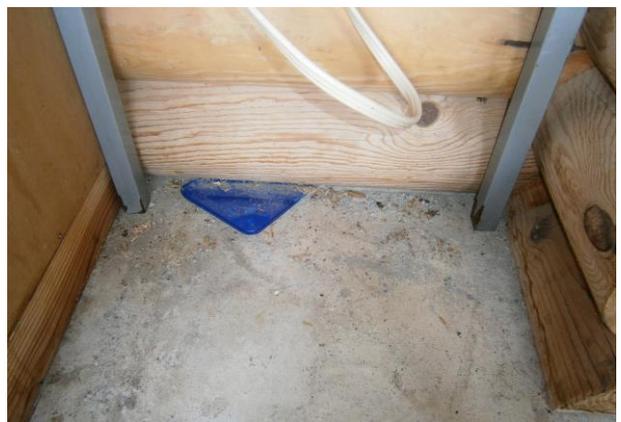
Figure 17: Ice-cream lid trapped under bottom log

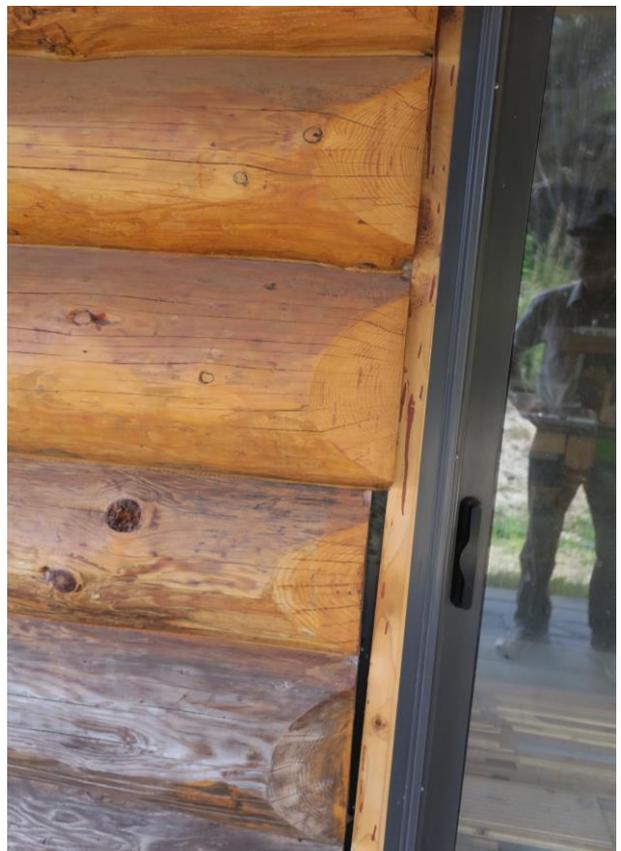
Most houses suffered damage through horizontal sliding between logs, to varying degrees. Sometimes this sliding was concentrated at one or two locations, as shown in Figures 18 and 19. More often the sliding was distributed between many logs as shown in Figures 20 and 21. In either case the sliding resulted in non-structural damage and some permanent distortion. Sliding was sometimes visible at the intersecting corner connections, especially for hand-hewn connections in large irregular logs as shown in Figure 22.

Figure 18: Localized sliding of logs

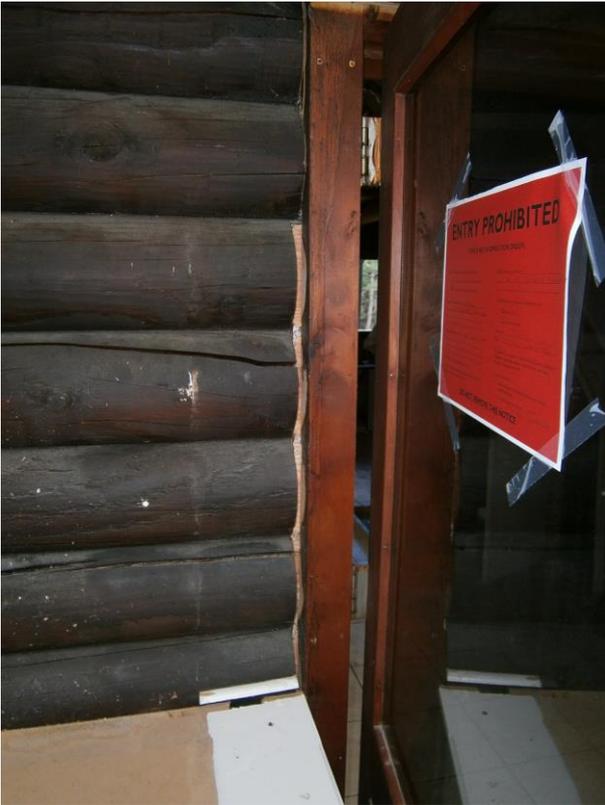
Figure 19: Localized sliding of logs

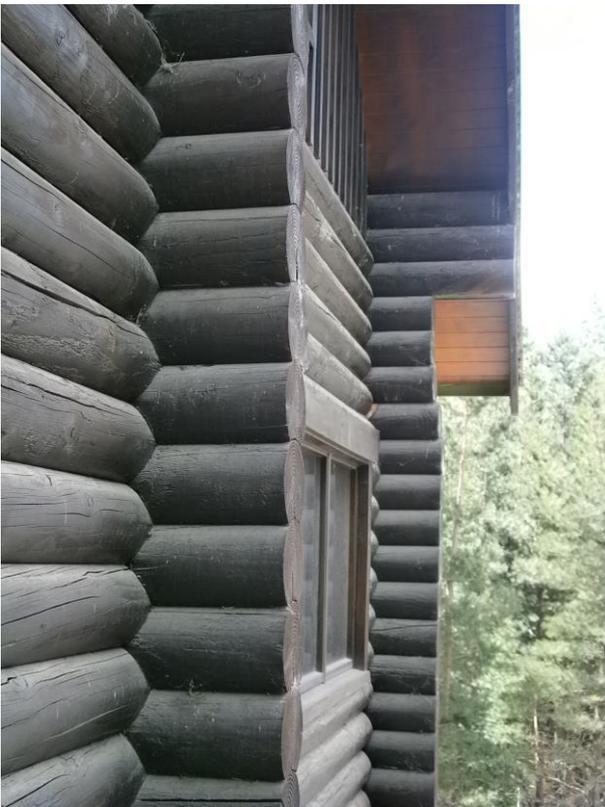
Figure 20: Sliding of logs resulting in residual drifts of the house

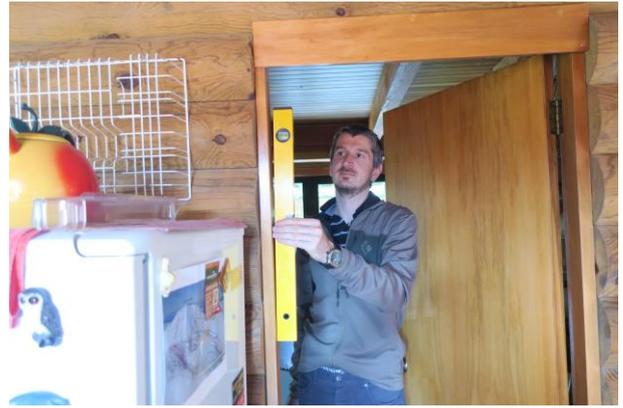
Figure 21: Sliding of logs resulting in residual drifts of the house

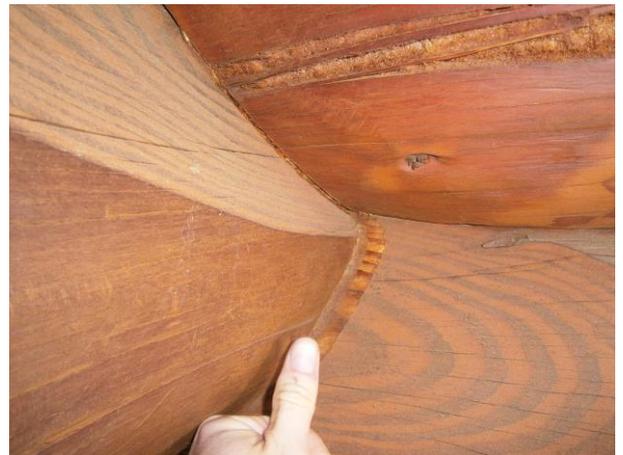
Figure 22: Sliding of the logs at corners

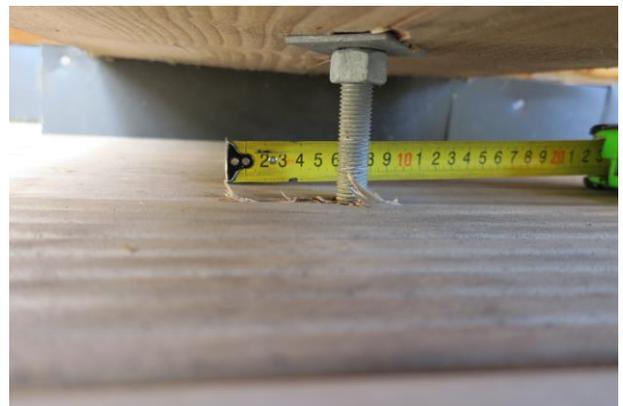
Figure 23 shows 60mm horizontal sliding where the bottom end of the tie-down rod was sitting on the top surface of timber decking.

Figure 23: Sliding of the logs measured at the vertical rod

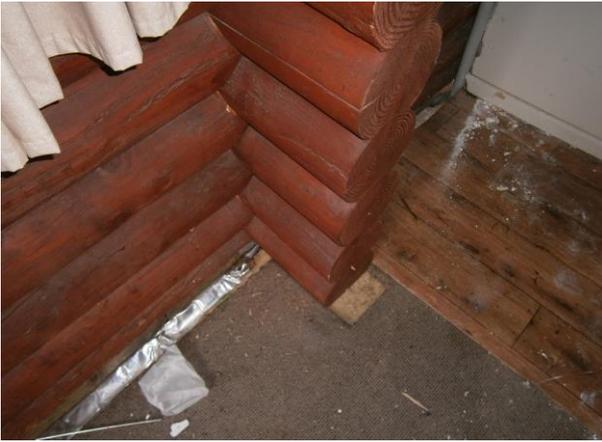
Figure 24 shows horizontal sliding above the lower suspended floor of the house in Figure 4. The large horizontal deformations in this house caused other structural damage including fracture of the post shown in Figure 25.

Figure 24: Sliding of the logs on suspended floor

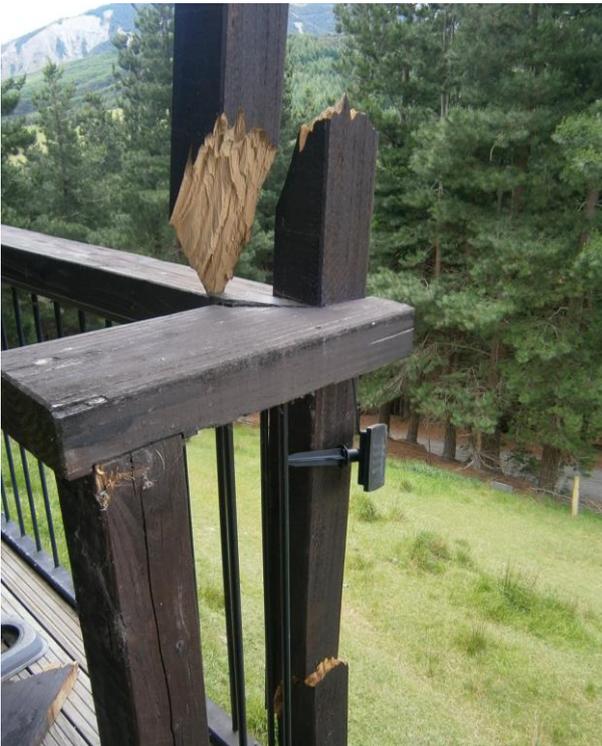
Figure 25: Fracture of veranda post due to excessive lateral movement

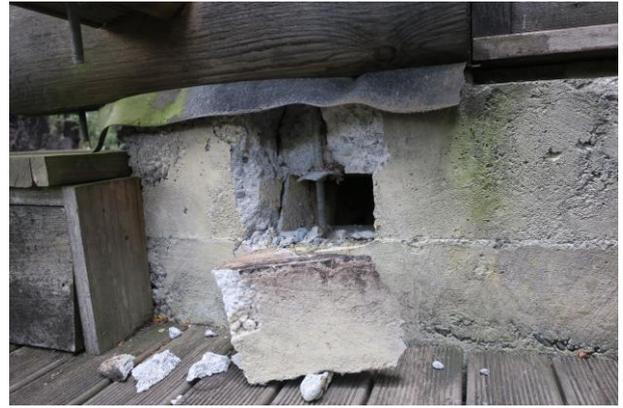
Figures 6 and 26 show damage to the unreinforced concrete foundation at a tie-down connection. Some rods were fractured by the tensile load as in Figure 27. Figures 28, 29 and 30 show visible damage at the bottom washers, where the damage is either a result of bending of the washer and potentially some tensile yielding of the steel rods, usually accompanied by wood crushing or wood fracture. In some cases there was crushing of the bottom log as shown in Figure 31. It is worth mentioning that some of the tension rods may also have become loose due to shrinkage of the logs, rather than yielding during the earthquake.

Figure 26: Damage to pocket in concrete foundation due to missing reinforcement

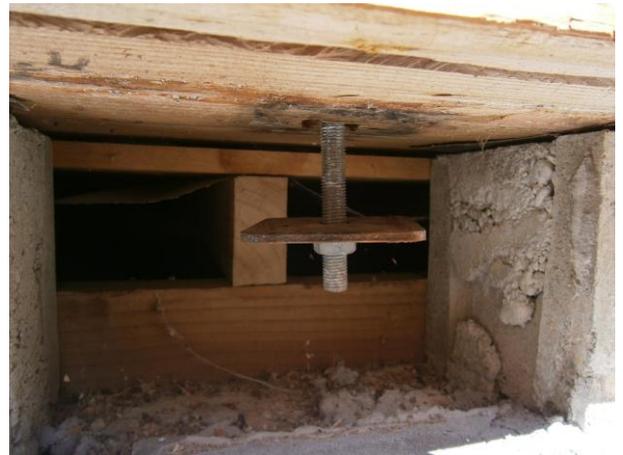
Figure 27: Fractured tie rod

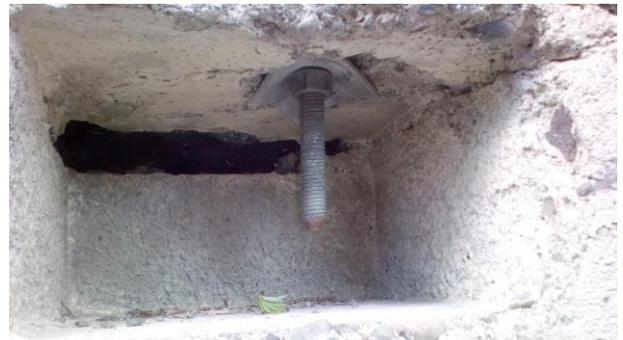
Figure 28: Bent washer in concrete pocket

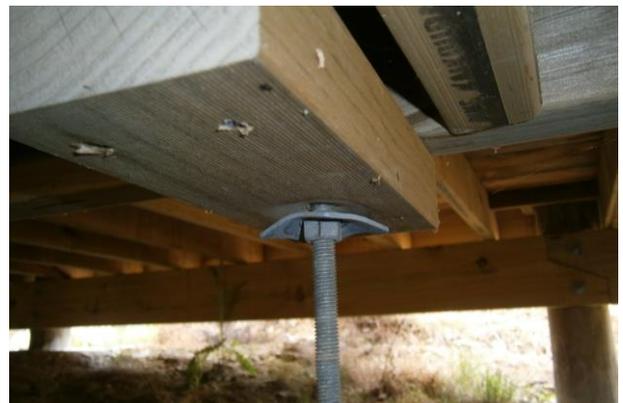
Figure 29: Bent washer and wood crushing in anchorage block

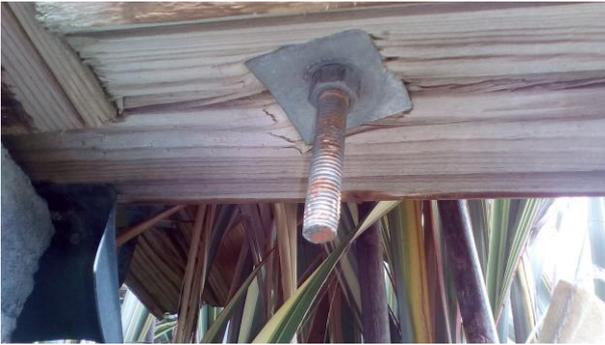
Figure 30: Bent washer and wood crushing in bottom log

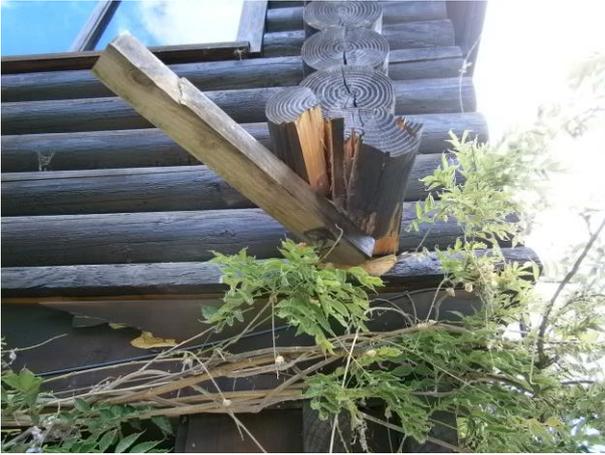
Figure 31: Crushing of bottom log

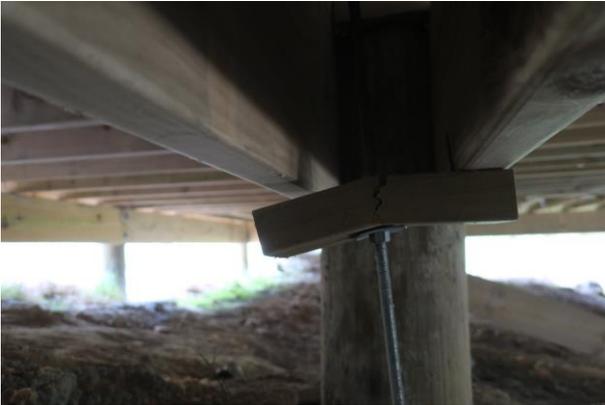
In houses with timber floors, there were some fractures of the short timber anchoring block between double joists as shown in Figure 32. Reinforcement provided by one owner after the earthquake is shown in Figure 33.

Figure 32: Failure of timber anchorage block

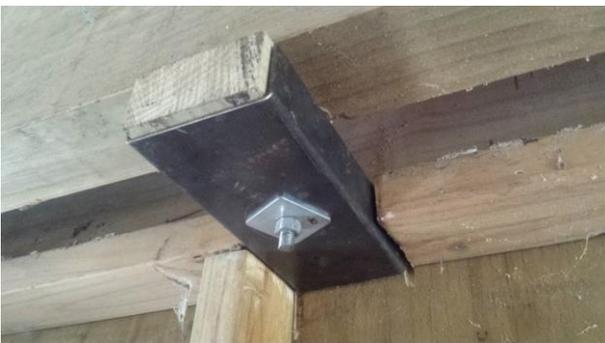
Figure 33: Reinforcement of timber anchorage with a steel profile

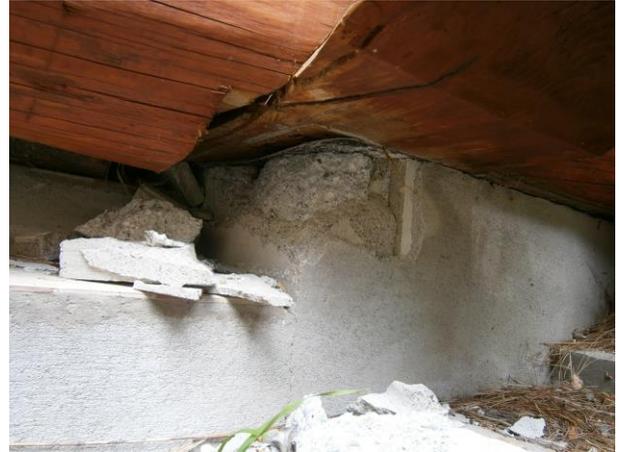
Most foundations performed very well, provided that the land remained stable. There were a few exceptions such as cracking off of the corner concrete shown in Figure 34.

Figure 34: Cracking and spalling of concrete due to large compression forces

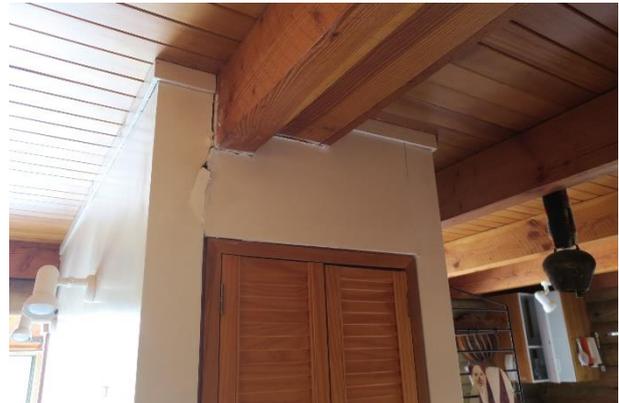
Almost all houses showed some non-structural damage to internal linings due to differential horizontal movements. Light timber framed walls at the same level as log walls could not accommodate the large lateral deformation of the log walls, resulting in cracked plasterboard lining especially around openings and at wall corners. Permanent lateral deformations resulted in obvious distortions and some doors which could not be closed. Typical cracking of gypsum plasterboard is shown in Figures 35 and 36.

Figure 35: Typical cracking of gypsum plasterboard

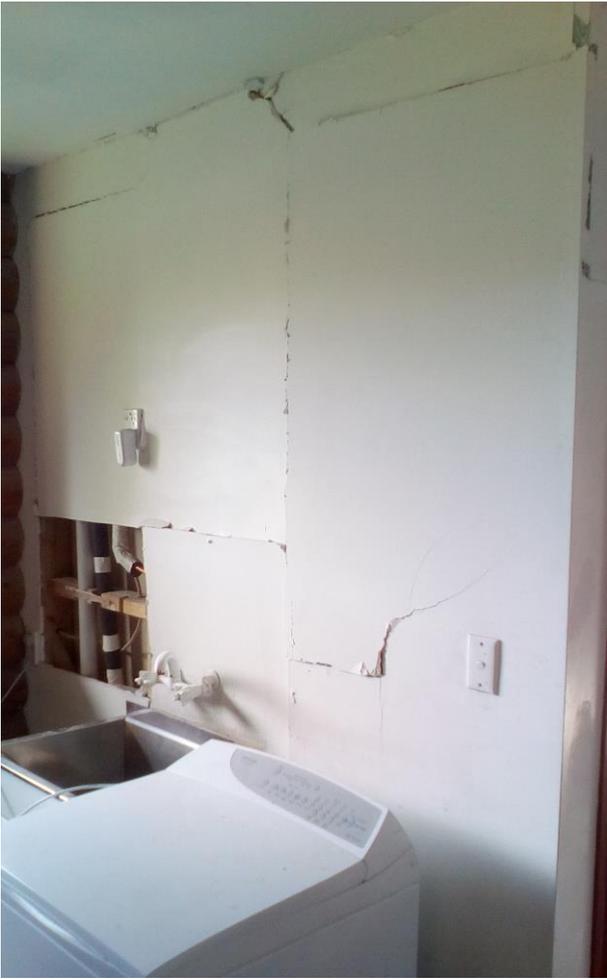
Figure 36: Typical cracking of gypsum plasterboard

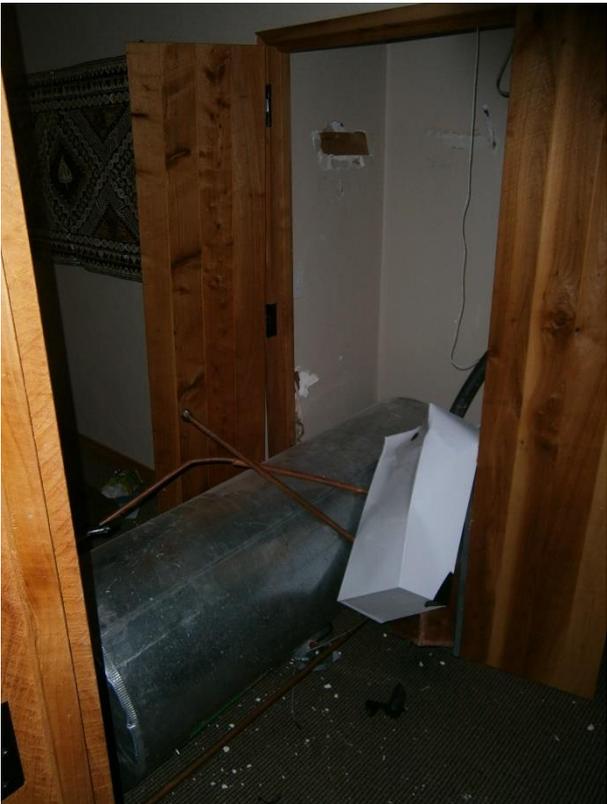
Some hot water cylinders with insufficient restraint fell over, causing additional damage to linings and plumbing, as shown in Figure 37.

Figure 37: Damage from insufficiently restrained water cylinder

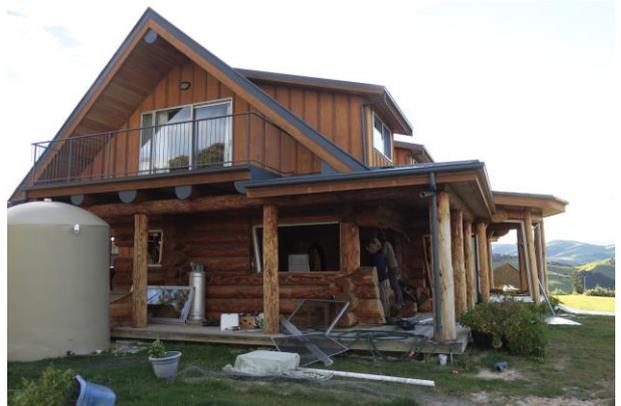
Figure 39: Two storey traditional log house with visible residual drift

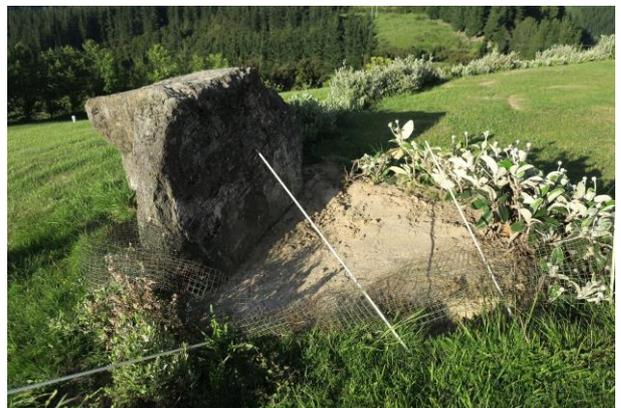
Figure 40: The rock close to the house was moved by about a meter by the earthquake

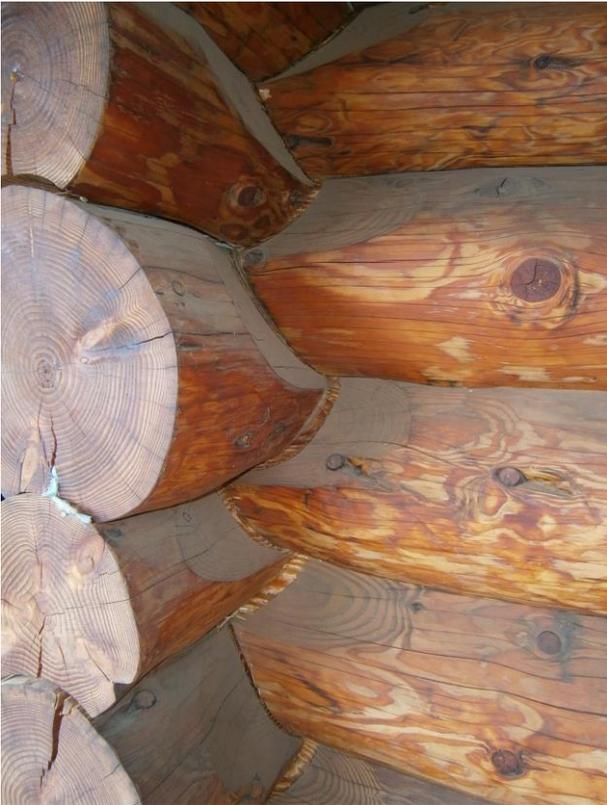
Figure 41: Permanent deformation in corner area

Permanent deformations from horizontal sliding between logs was much larger in this house than in houses at Mt Lyford, as shown in Figures 41 and 42. There was unusual movement around the circular steel frame of the front door shown in Figure 43 where there was upwards movement of logs due to the shape of the door frame. The picture trapped under the bottom log in Figure 44 shows that there was significant vertical movement of some log walls.

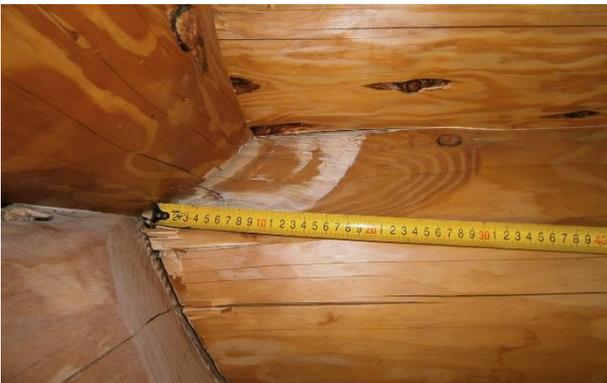
Figure 42: Permanent deformation in corner area

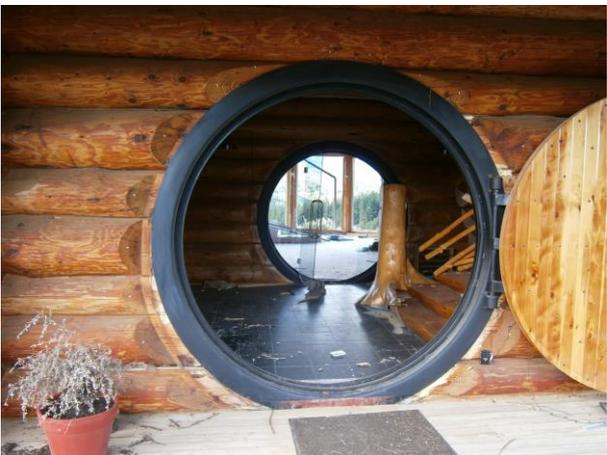
Figure 43: Large deformation around very stiff circular door frame

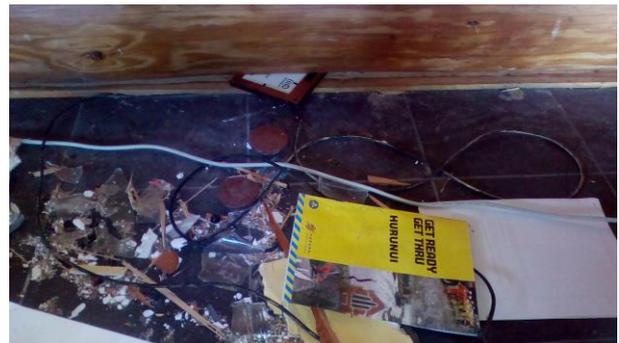
Figure 44: Trapped picture frame under sill log

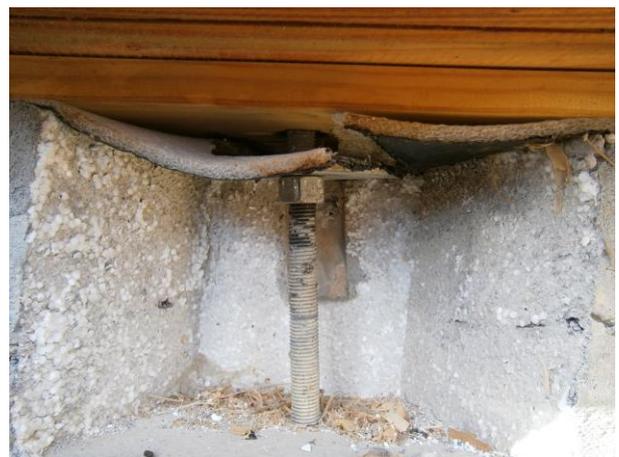
Figure 45 shows yielding of tensile tie rods. Significant damage occurred at the bottom log connection to the concrete slab, especially where there was a bottom half-log. A typical undamaged whole log is shown in Figure 46, whereas Figures 47, 48 and 49 show severe splitting of bottom half-logs in the transverse direction. This splitting was accentuated by the presence of tie rods (to resist uplift), dowels (to resist shear) and pre-cutting of logs at door and window opening to control shrinkage.

Figure 45: Yielding failure or fracture of tension rod

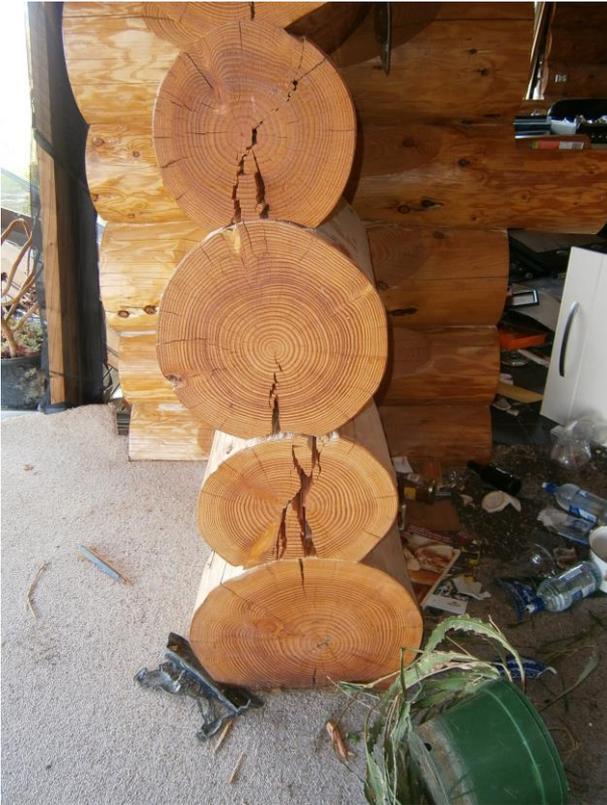
Figure 46: Initiation of splitting in logs, undamaged bottom log

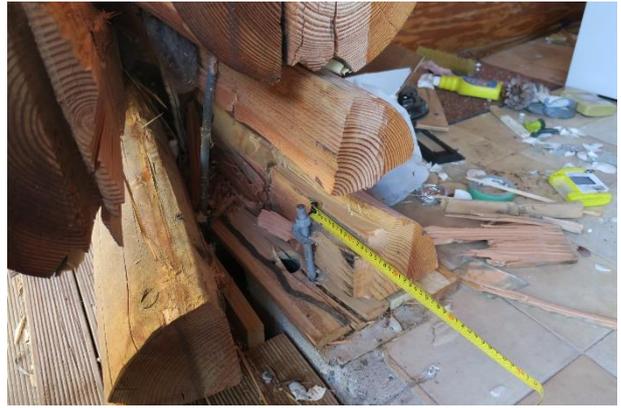
Figure 48: Splitting of logs weakened by tie rods and shear dowels

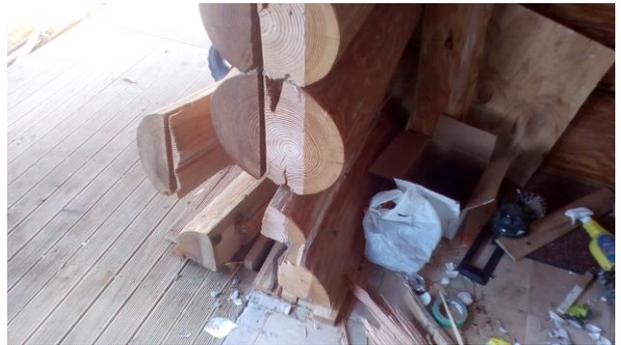
Figure 49: Splitting of bottom log weakened by vertical slot at door frame

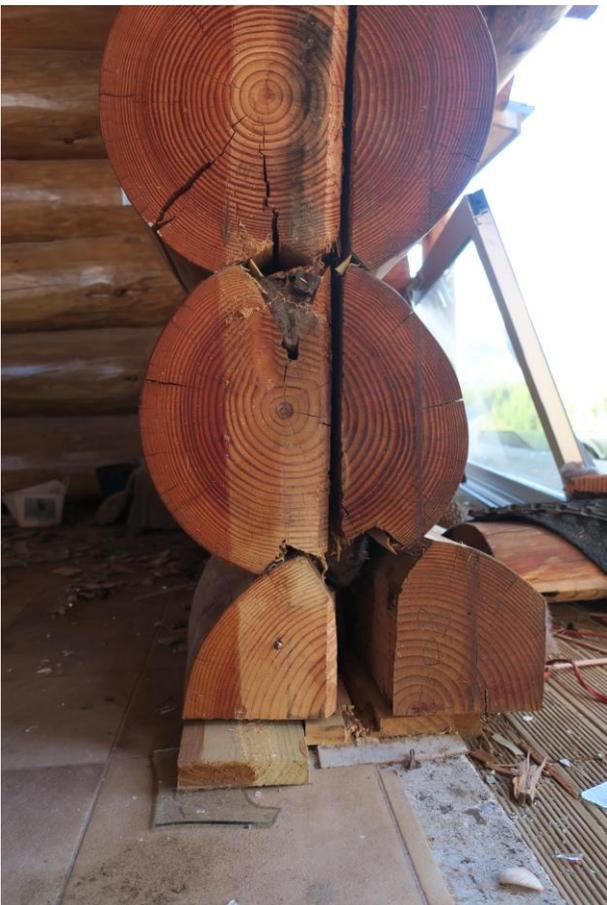
Figure 47: Splitting of bottom log

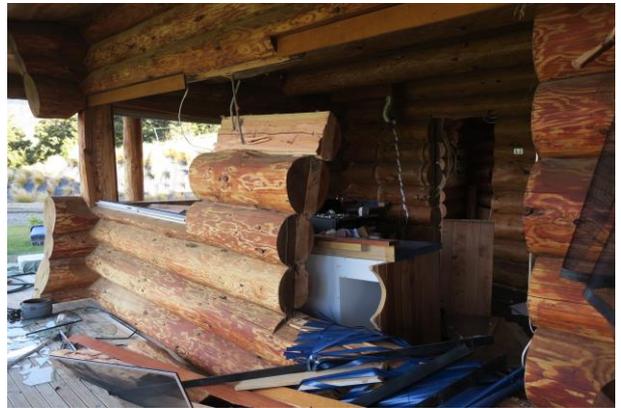
Walls with no cross logs were more badly affected, as shown in Figures 50, 51 and 52 where some logs have split in half exposing the tie-down rods and shear dowels.

Figure 50: Wall stability failure and splitting of logs

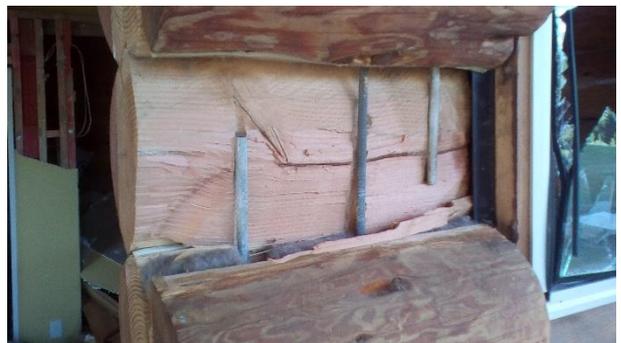
Figure 51: Splitting of log

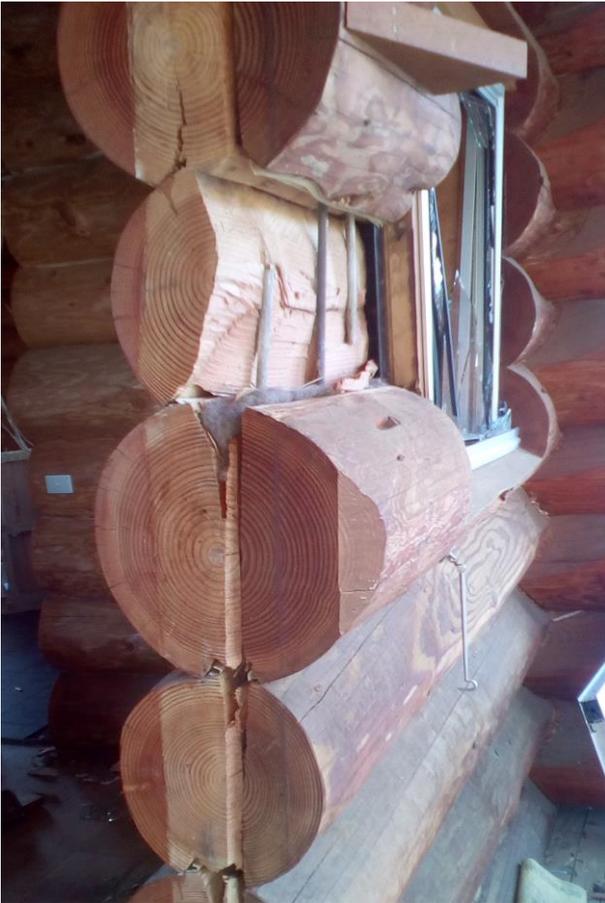
Figure 52: Splitting of log due to weakening by dowels, tie rod and vertical slot at door frame

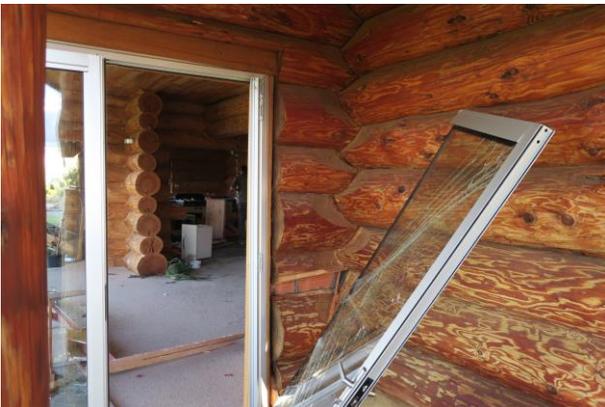
These large movements caused massive non-structural damage, as expected. Some typical downstairs damage is shown in Figures 53 and 54, and in Figure 55 which shows the kitchen and the hot water cylinder. Damage in the upper storey was much less, as shown in Figure 56.

Figure 53: Typical damage to doors and windows due to large horizontal deformation

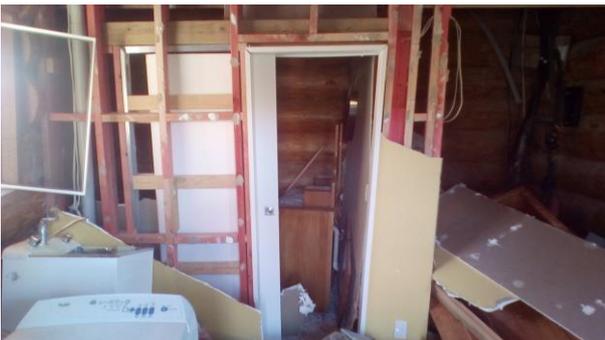
Figure 54: Typical damage to light timber framing walls lined with plasterboard

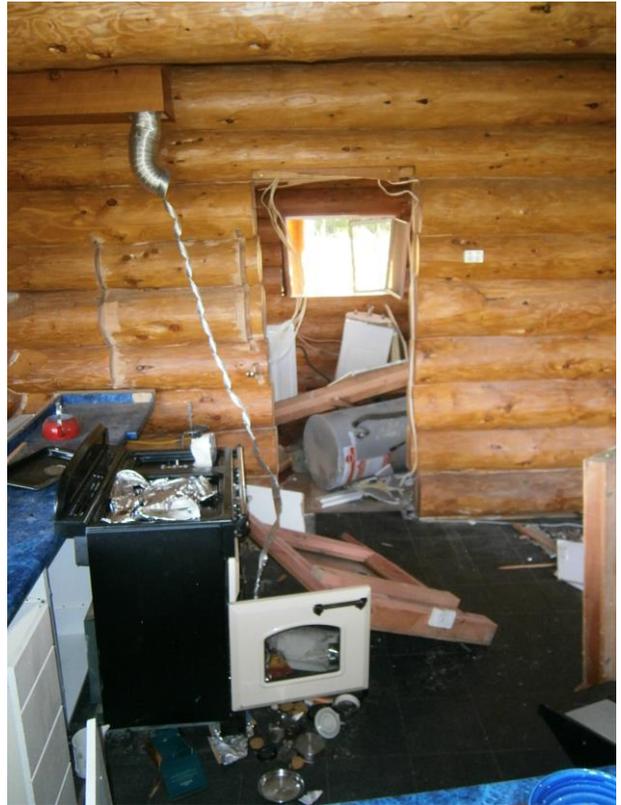
Figure 55: Typical damage from falling or sliding of heavy objects

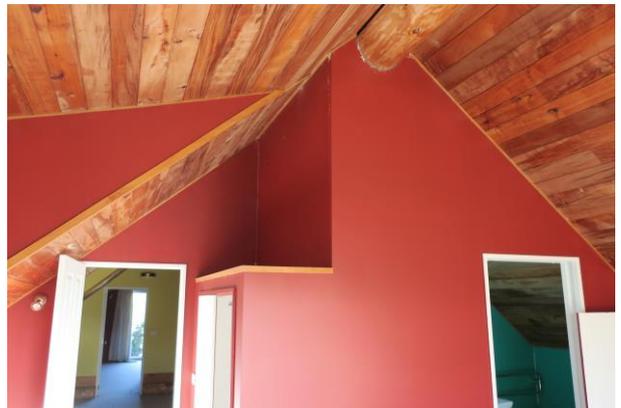
Figure 56: Damage in the upper storey was very limited
