LOG HOUSE PERFORMANCE IN THE 2016 KAIKOURA EARTHQUAKE

Andy Buchanan¹ and Daniel Moroder²

This paper describes the performance of log houses in the 2016 Kaikoura earthquake. Most of these houses are in the Mt Lyford village 45 km south-east of Kaikoura.

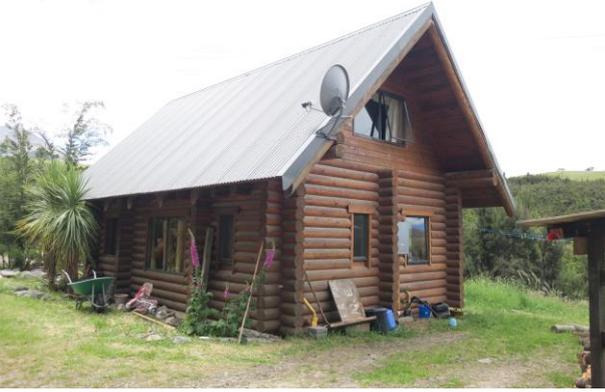
Figure 3: Two storey log house with slab on grade foundation

In a few houses with poor anchorage, the whole house slid horizontally on the foundations, by up to 100mm. Figure 15 shows local sliding of the house in Figure 3. Sometimes the sliding was at the top of the bottom half-log as shown in Figure 16. In a few exceptional cases, objects were trapped under the bottom log, showing that there had been considerable upward movement of the whole wall for a few moments during the earthquake as shown in Figure 17.

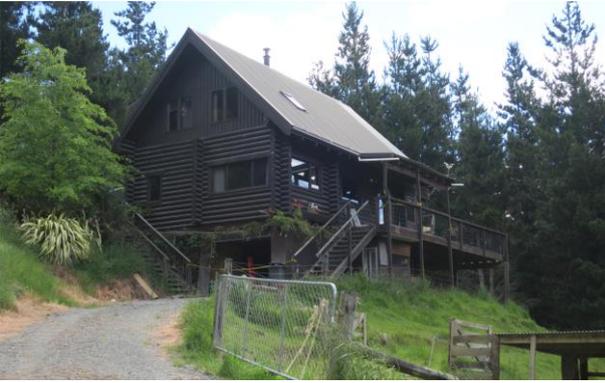
Figure 4: Two storey log house on slope with pole foundation

Figure 24 shows horizontal sliding above the lower suspended floor of the house in Figure 4. The large horizontal deformations in this house caused other structural damage including fracture of the post shown in Figure 25.

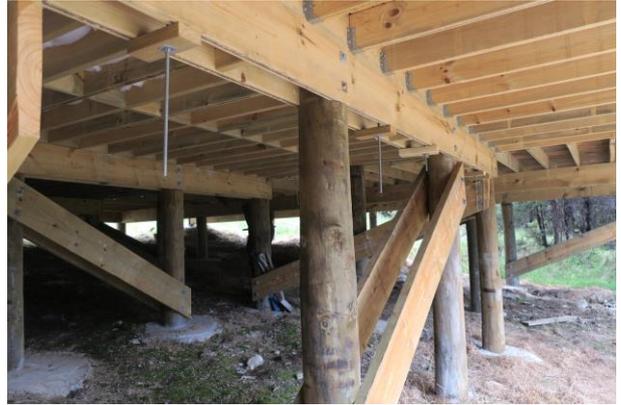
Figure 8: Pole supports with diagonal sub-floor bracing

Lateral loads below timber ground floors are usually resisted by the cantilever action of short braced piles or by diagonal timber bracing between longer timber poles. No serious damage was observed in the sub-floor bracing of any houses (Figure 8).

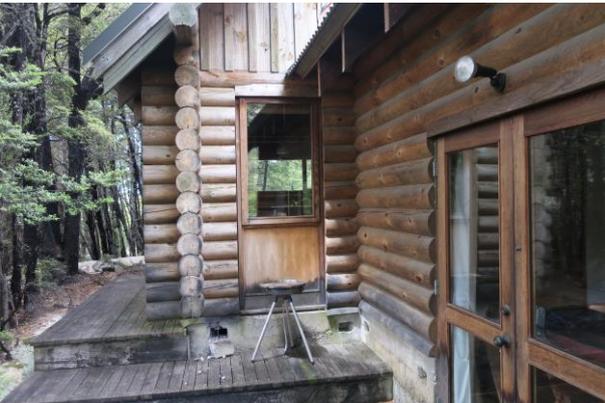
Figure 6: Two storey log house with slab on grade foundation

Figures 6 and 26 show damage to the unreinforced concrete foundation at a tie-down connection. Some rods were fractured by the tensile load as in Figure 27. Figures 28, 29 and 30 show visible damage at the bottom washers, where the damage is either a result of bending of the washer and potentially some tensile yielding of the steel rods, usually accompanied by wood crushing or wood fracture. In some cases there was crushing of the bottom log as shown in Figure 31. It is worth mentioning that some of the tension rods may also have become loose due to shrinkage of the logs, rather than yielding during the earthquake.

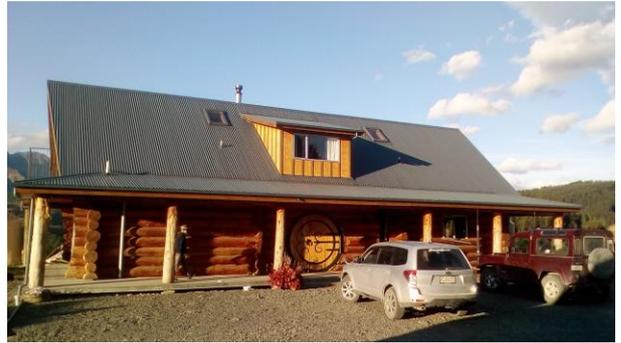
The authors were directed to one particular log house about half way between Mt Lyford and Waiau, which suffered extreme near-fault shaking, leading to extensive damage. This house is described separately to the others because of the higher level of damage. It is a new house, of large traditional log house construction on a concrete slab, shown in Figures 38 and 39. An indication of the extreme level of local shaking is provided by the rock on the lawn shown in Figure 40, which jumped to a new position over one metre away. The damage to this house is considered to be the result of exceptional ground movement rather than any major deficiencies in the design or construction. Local acceleration amplification due to the local topography, also known as the 'hill crest effect' [9], could have caused the increased shaking of the house.

Figure 38: Two storey traditional log house
