# Building Enclosure & Energy Performance of Log & Timber Homes

## Testing and Modeling Summary

PREPARED FOR: BC Log and Timber Frame Home Market Expansion Project

SUBMITTED BY RDH Building Engineering Ltd.  
 224 West 8th Avenue  
 Vancouver, BC V5Y 1N5  
 Canada

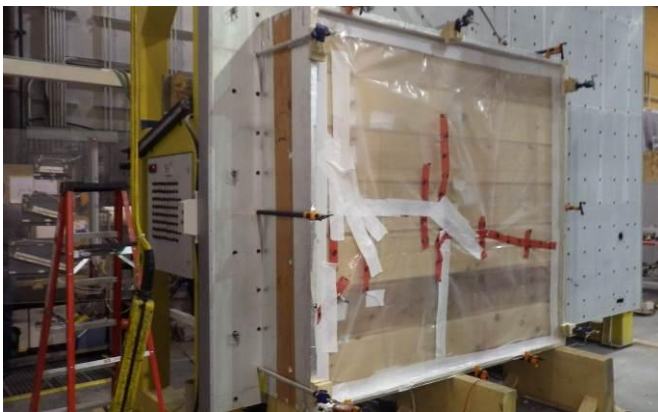
Fig.2.1 Front view of Cascadia Windows in-house Test Wall

Testing of the log home wall assemblies was undertaken using the testing facility at the Cascadia Windows Ltd.'s manufacturing facility in Langley, BC (Fig.2.1 and Fig.2.2). The Cascadia facility is capable of testing specimens as large as 16' x 12'. This apparatus can be used to perform water penetration resistance testing, air leakage testing, and structural testing.

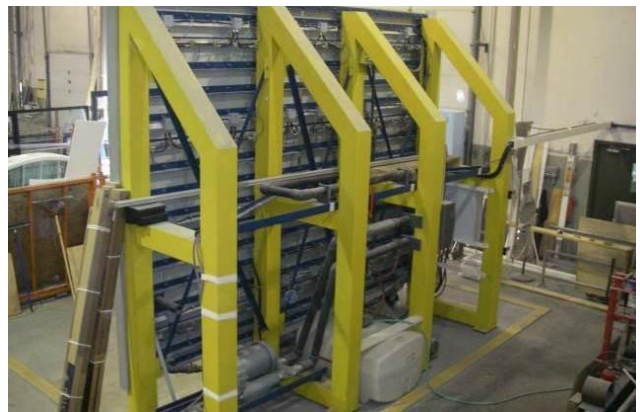
Fig.2.2 Rear view of Cascadia Windows in-house Test Wall

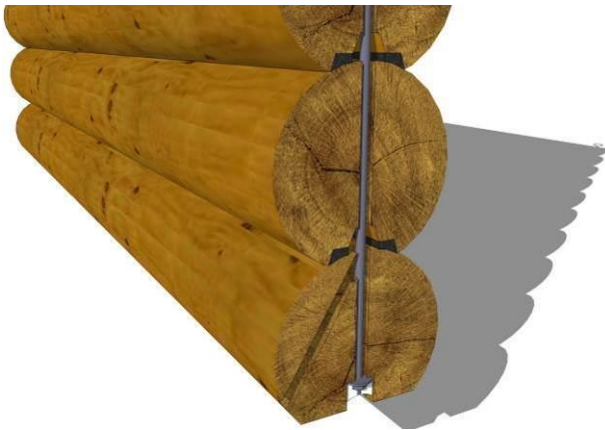
Fig.2.3 Rendering of how the lateral groove and venting of the log home test wall was achieved.

The third and fourth modules included provisions to vent the lateral groove to the exterior as part of supplementary testing in an attempt to demonstrate pressure moderation potential for the lateral groove. The lateral grooves were vented with two oversized tie-down rod chases that ran vertically the height of the test wall and exited to the exterior side of the wall on

a diagonal in the bottom log (Fig.2.3). The walls were tested with the diagonal holes sealed (unvented) and open (vented) (Fig.2.4). Fig.2.5 and Fig.2.6 are elevations of Modules 3 and 4 indicating the location of the pressure taps. The pressure taps are used to measure the pressure difference between the lateral grooves and exterior.

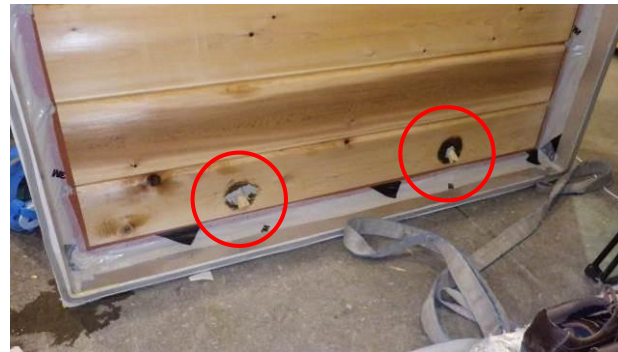
Fig.2.4 Log home test wall with plug in the vent holes sealed.

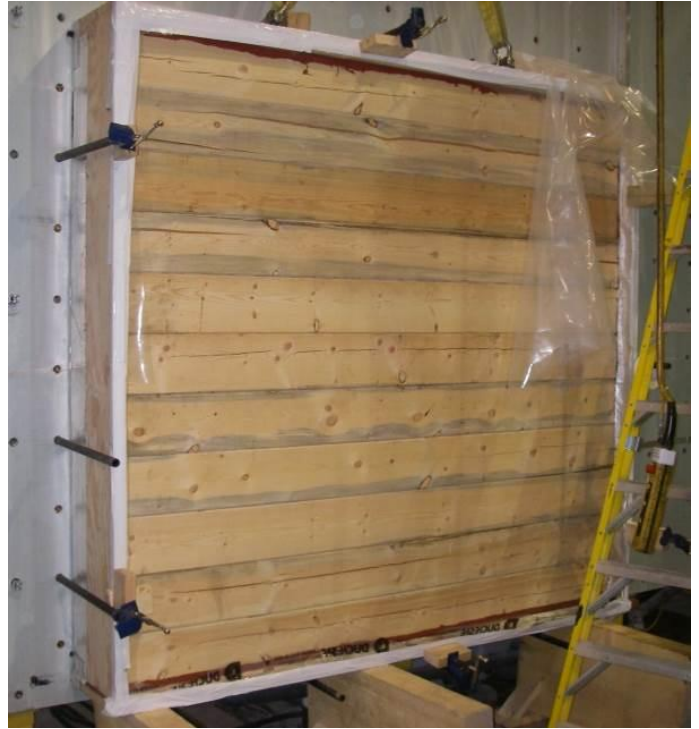
Fig.2.7 Module 1

Fig.2.8 Module 2

- Module 1: hand crafted, scribed fit, Douglas Fir logs with a log diameter of 14", and EMSeal gasket either side of the lateral groove (Fig.2.7).
- Module 2: mountain pine beetle killed manufactured d-logs, 5 1/2" wide by 7 1/2" tall, double tongue and lateral groove with Loctite PL Premium Polyurethane Construction Adhesive (Fig.2.8).
- Module 3: squared Red Cedar logs, 11 1/2" by 11 1/2", with a tongue and lateral groove with a p-gasket at either side (0).

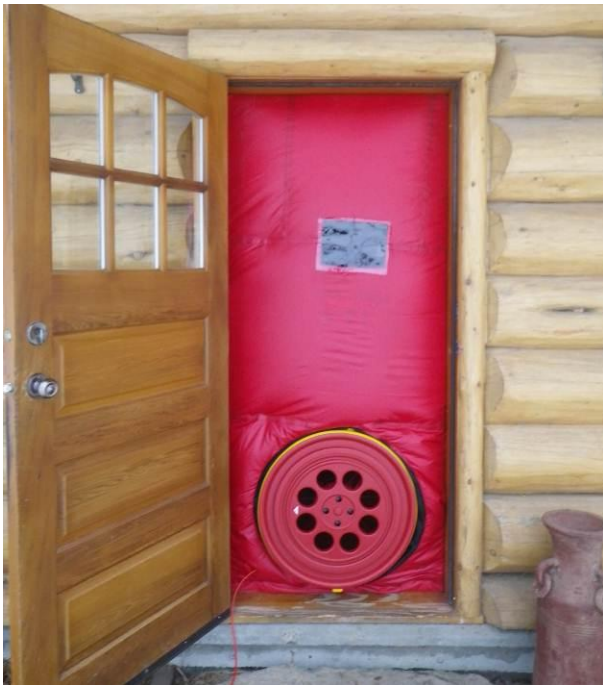
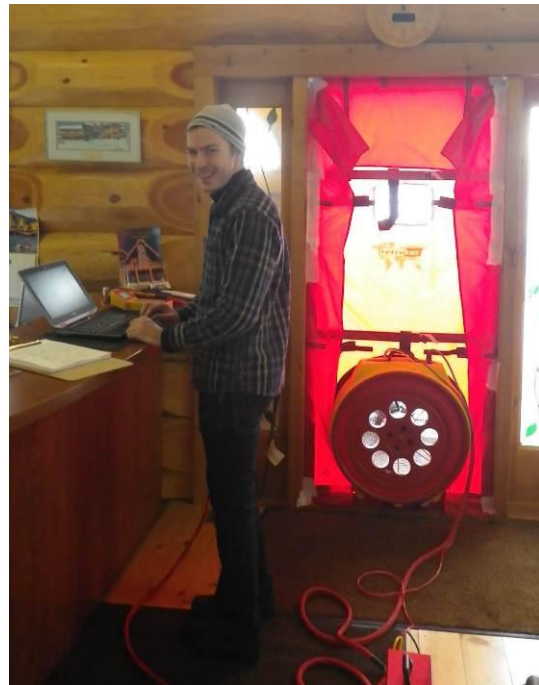
Fig.3.1 Blower door test apparatus viewed from the exterior (left) and the interior (right).

The air-tightness of a house is measured by conducting a blower door test. For this test, the house is pressurized and the air leakage rate of the house is calculated based on the fan speed and the pressure difference between inside and outside. Section 3.1 provides additional details on the blower door testing methodology.

The air-tightness testing procedure followed the methodology for the EnerGuide for Houses air-tightness test. This methodology follows the standard CGSB 149.10 M86 “Determination of the Air-tightness of Building Envelopes by the Fan Depressurization Method”. The EnerGuide test requires a modification to the CGSB standard; that the house must be tested “as operated” (under normal operating conditions, without sealing intentional openings such as dryer vents, combustion air inlets, and fireplace chimneys). The EnerGuide test also includes an additional step that is not in the CGSB standard; testing the level of house depressurization with all of the exhaust appliances operating to check whether an appliance may be spilling combustion products. However, this test was not completed on the four log and timber frame houses since combustion spillage was not a focus of this study.

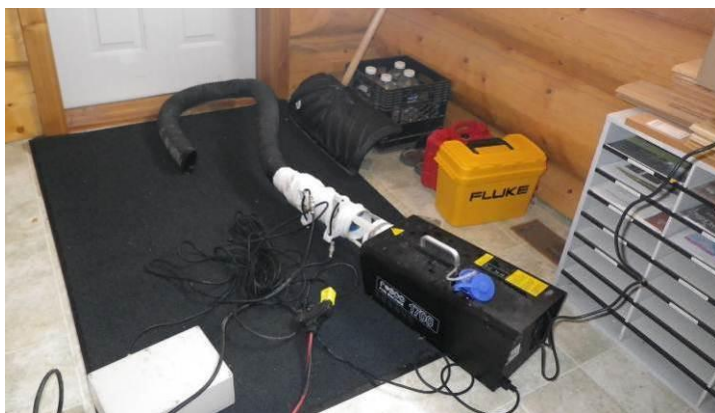
Fig.3.2 Theatrical fog machine smoke testing apparatus.

In addition to the EnerGuide test procedure, additional qualitative testing was completed by pressurizing the house and using smoke and infrared thermography to locate air leakage sources. After the EnerGuide pressurization test was complete, the fan was turned around in order to pressurize the house. The house was pressurized to 50 Pa, and smoke was generated inside the house using a theatrical fog machine (Fig.3.2). Areas where smoke was visible at the outside were recorded as air leakage paths.

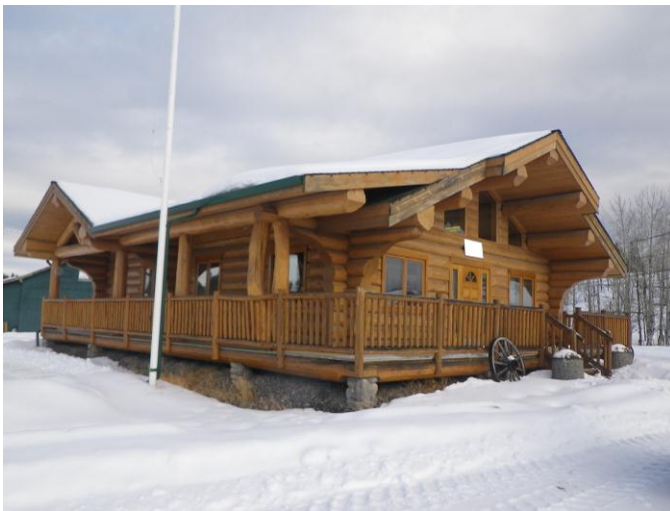
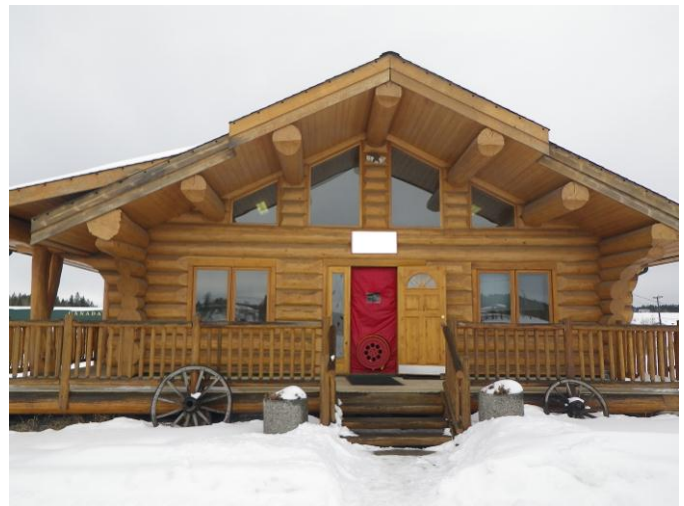
Fig.3.3 Air-tightness test house #1, 100 Mile House, BC.

The first test house is a log home in 100 Mile House, BC, built in 2003 (Fig.3.3). The house is one-storey with a cathedral ceiling and a heated crawlspace. Heating is provided by a gas furnace in the crawlspace. The house contains logs of four different species: spruce, pine, fir and cedar. The logs were measured to have a diameter of approximately 14". Air sealing of the log walls was completed by sealing joints at the exterior. Crawlspace walls had 2" XPS insulation inside of the concrete wall and acoustically sealed polyethylene placed over the insulation

Floor plans were not available for this house; however the area was measured on site. The floor area of the house is approximately 1,110 sf. The total enclosure surface area (including crawlspace and slab) is approximately 3,870 sf, and the total volume (including the heated crawlspace) is approximately 17,500 ft<sup>3</sup>.

The depressurization test resulted in an air-tightness of 2.82 ACH<sub>50</sub>. This corresponds to an equivalent leakage area of 86.3 in<sup>2</sup> at 10 Pa, or 46.3 in<sup>2</sup> at 4 Pa.

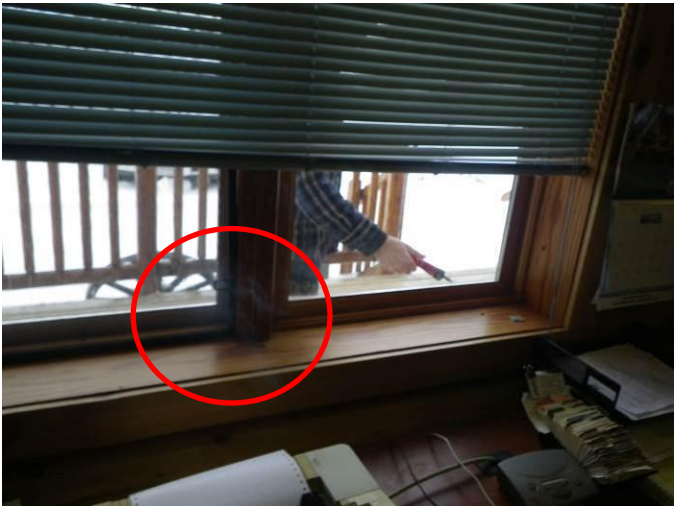
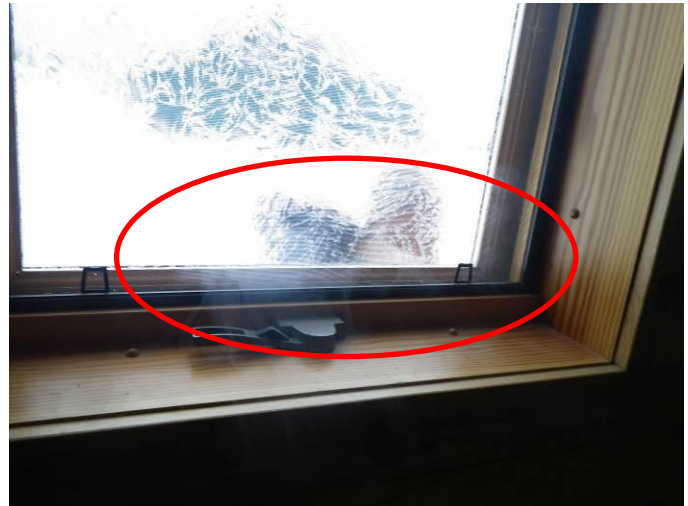
Fig.3.4 Smoke infiltration observed at operable windows during smoke pencil testing from the exterior under depressurization.

Smoke testing while the house was depressurized showed air leakage around the windows and doors, particularly at operable windows (Fig.3.4). At windows, leakage appeared to occur both around the frame (between the window and the rough opening), as well as between the sash and the frame at operable units. A particularly large amount of leakage was observed at the back door to the house.

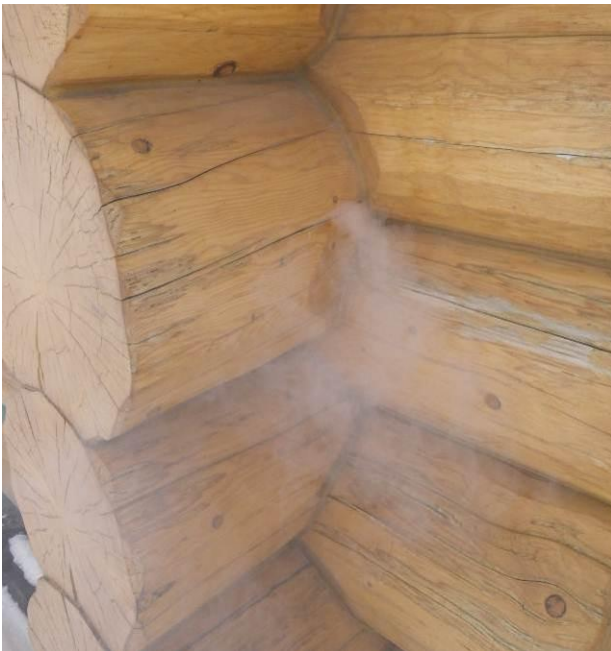
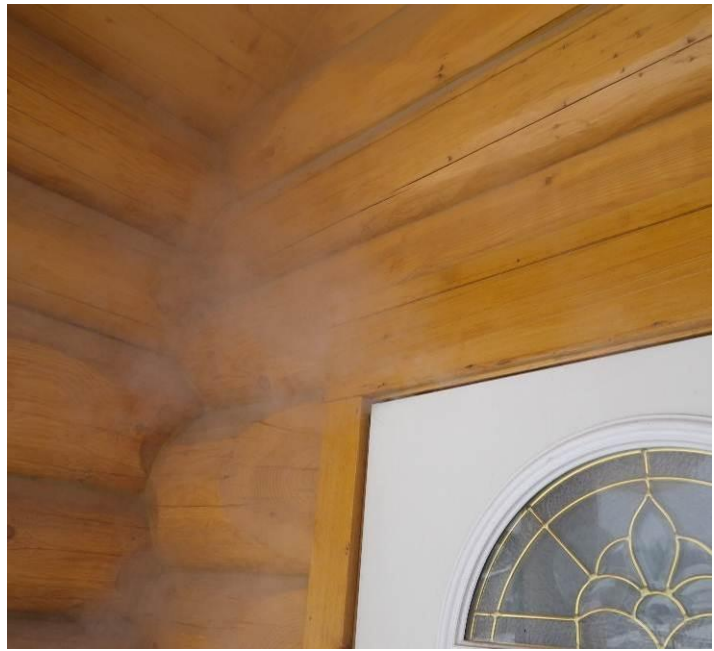
Fig.3.5 Smoke infiltration observed at corner joints and exterior door during smoke testing from the interior under pressurization.

Smoke testing while the house was pressurized showed air leakage around the windows and doors, as well as through the corner joints in the log wall (Fig.3.5). A significant amount of leakage was seen through the corner joint.

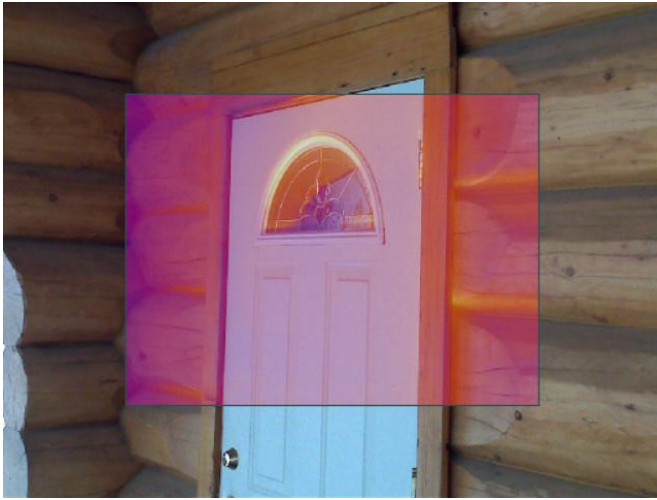
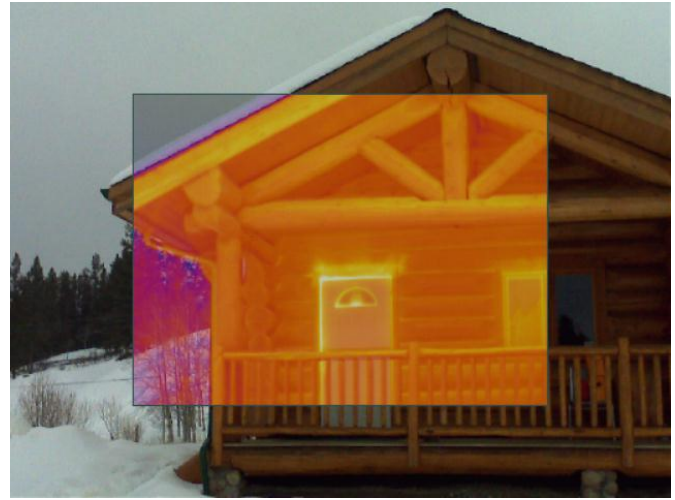
Fig.3.6 IR photo of the door during depressurization (left) and pressurization (right), showing air leakage around the door during pressurization.

Fig.3.6 and Fig.3.7 show IR images during depressurization and pressurization. As with smoke testing, the IR images showed air leakage occurring at windows and doors, and through log wall corner joints.

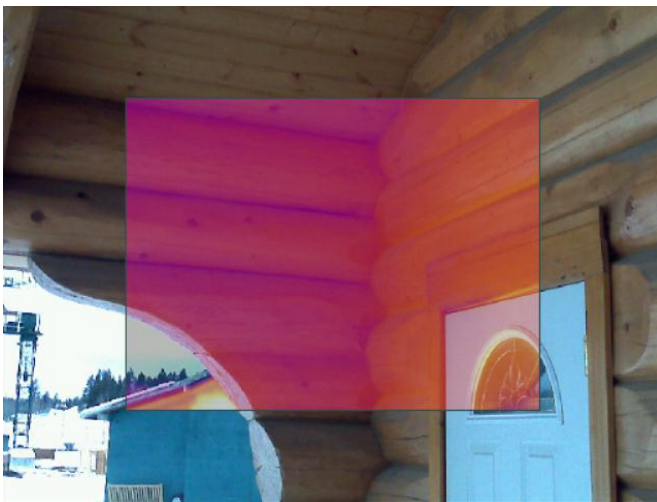
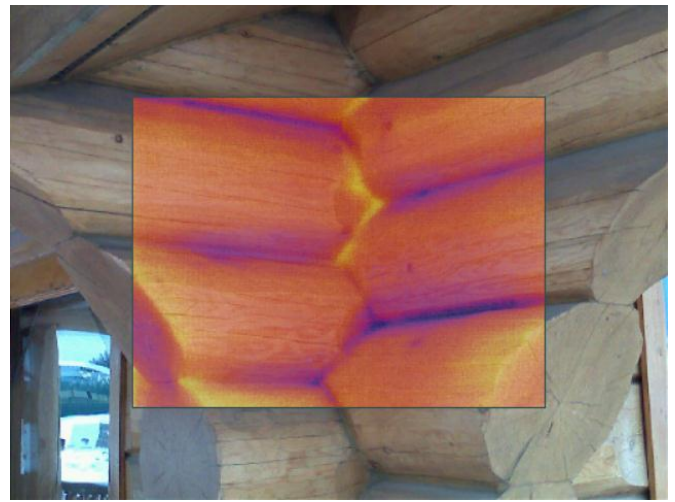
Fig.3.7 IR photo of a joint during depressurization (left) and pressurization (right), showing air leakage through the joint during pressurization.

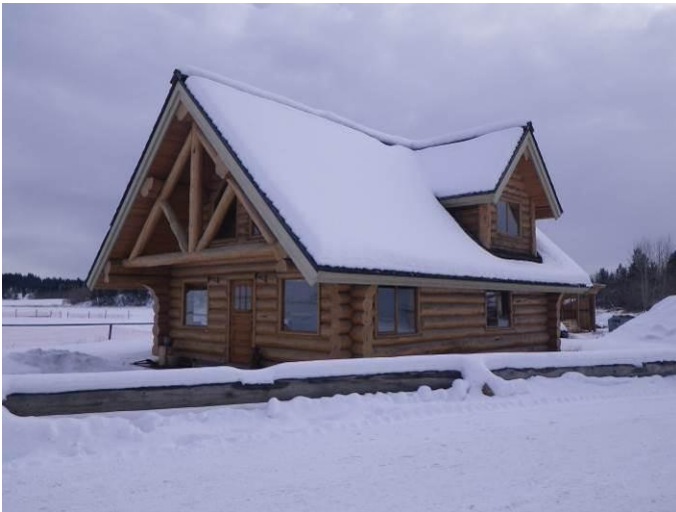
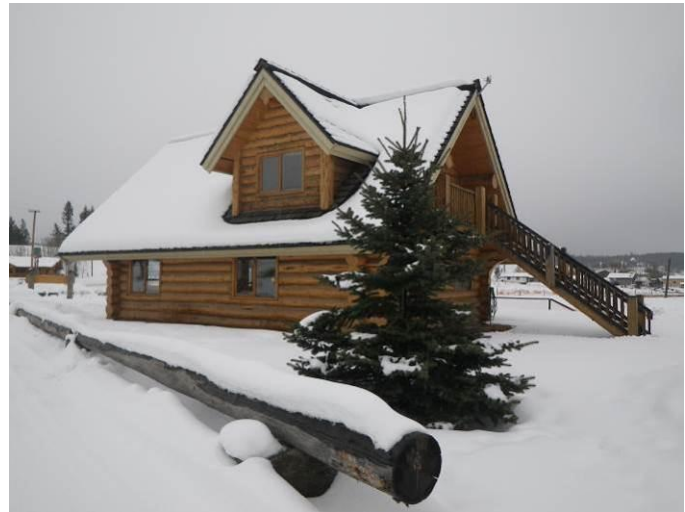
Fig.3.8 Air-tightness test house #2, 100 Mile House, BC.

The second test house is a log home located in 100 Mile House, BC, built in 2003 (Fig.3.8). This house is two-storeys (one-storey plus loft) with a cathedral ceiling and an insulated crawlspace. Heating is provided by electric baseboards. The house contains Lodgepole Pine logs which were measured to have a diameter of approximately 14". Air sealing of the log walls was completed by sealing joints at the interior. Crawlspace walls had 2" XPS insulation inside of the concrete wall; though it was noted the insulation stopped approximately 2" short of the top of the crawlspace wall.

The area and volume of this house were calculated from floor plans. The floor area of the house is approximately 1,100 sf (660 sf at the first floor plus a 440 sf loft). The total enclosure surface area (including crawlspace and slab) is approximately 3,270 sf, and the total volume (including the crawlspace) is approximately 13,400 ft<sup>3</sup>.

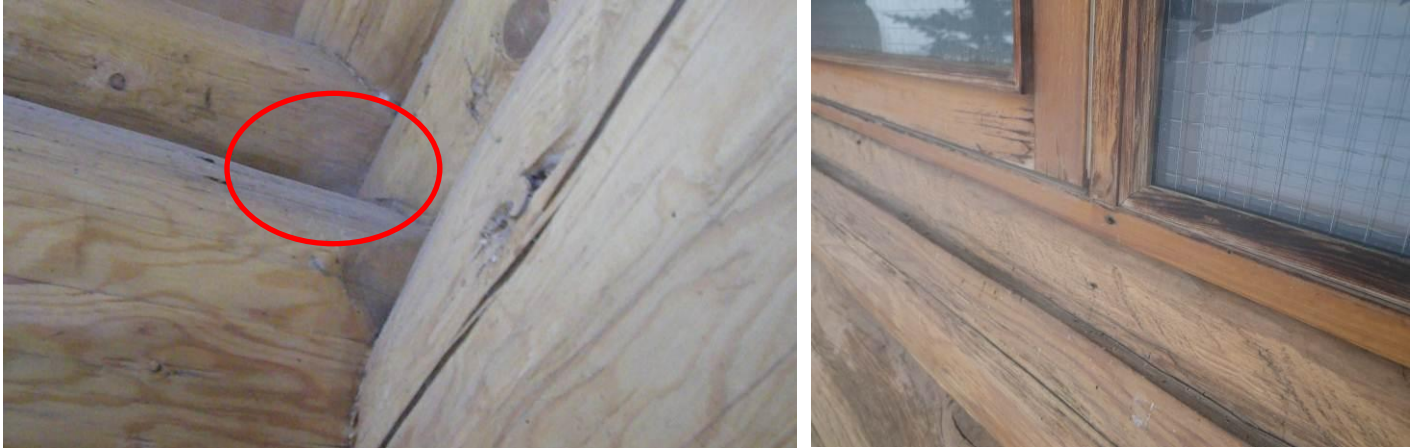
Fig.3.9 Smoke infiltration observed at corner joint (left) and around operable windows (right) during smoke testing from the interior under pressurization.

Smoke testing using a smoke pencil while the house was depressurized showed air leakage at two operable windows (bathroom window and one first floor back window); no leakage was observed through the other fixed and operable windows. Smoke testing using a theatrical fog machine while the house was pressurized showed air leakage through the corner joints in the log wall and around operable windows (Fig.3.9).

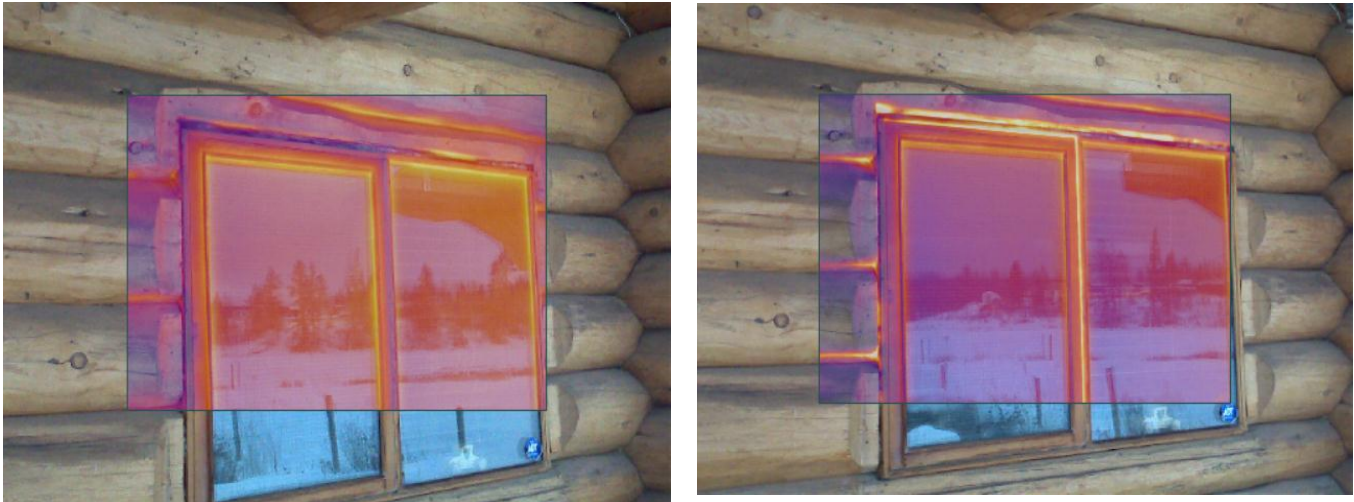
Fig.3.10 IR photo of a window during depressurization (left) and pressurization (right), showing air leakage during pressurization around the window frame and at joints between logs where the logs meet the window.

Infrared (IR) thermography photos were taken of the house during depressurization and during pressurization. Fig.3.10, Fig.3.11 and Fig.3.12 show IR images during depressurization and pressurization. Fig.3.13, Fig.3.14 and Fig.3.15 show additional IR images taken during pressurization where no depressurization photo exists, but air leakage paths can still be identified. The IR images show air leakage occurring at windows, doors and joints.

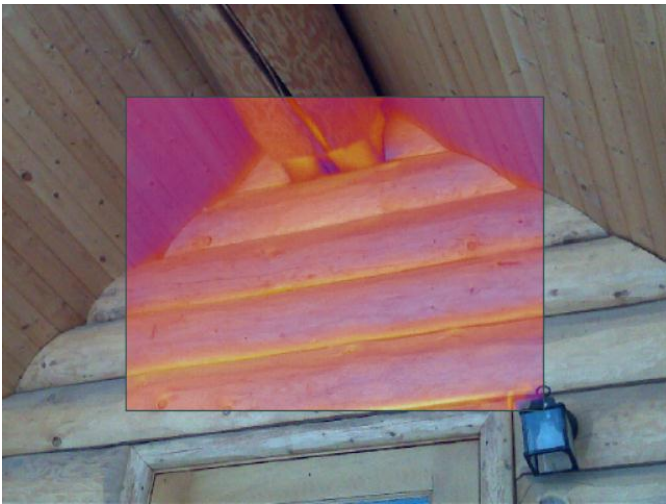
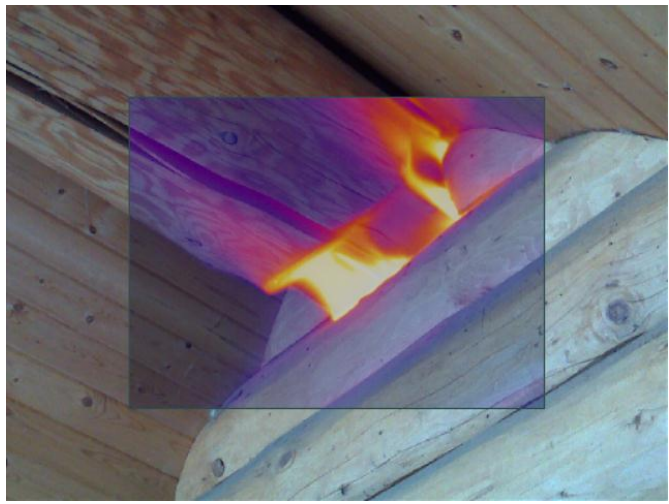
Fig.3.11 IR photo of the gable and roof overhang during depressurization (left) and pressurization (right), showing air leakage at the joint during pressurization.

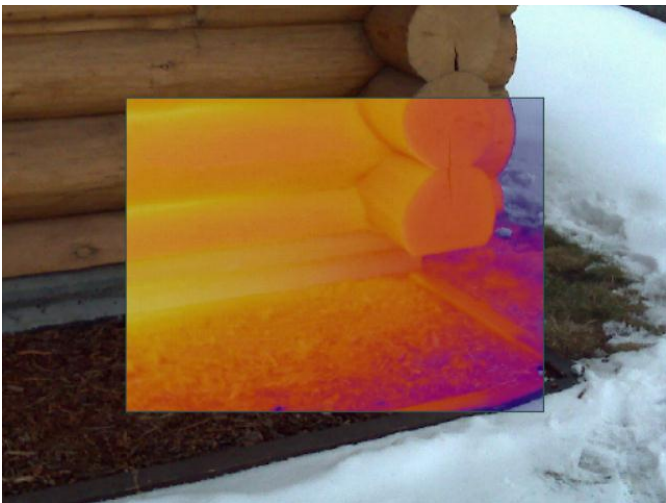
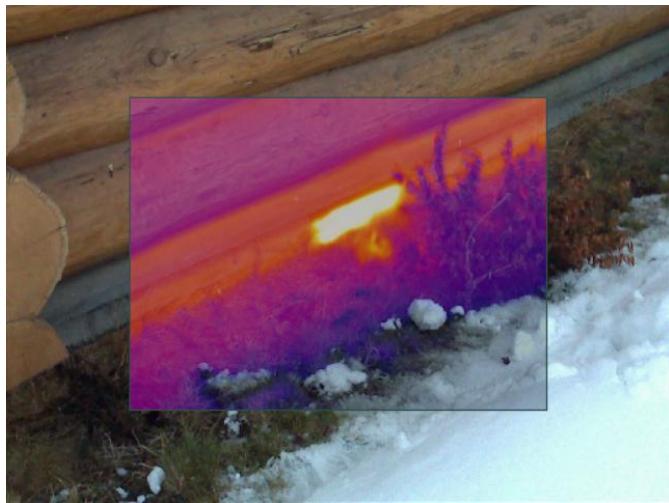
Fig.3.12 IR photo of the foundation (crawl space) wall and log wall interface during depressurization (left) and pressurization (right), showing air leakage through the crawl space vent during pressurization.

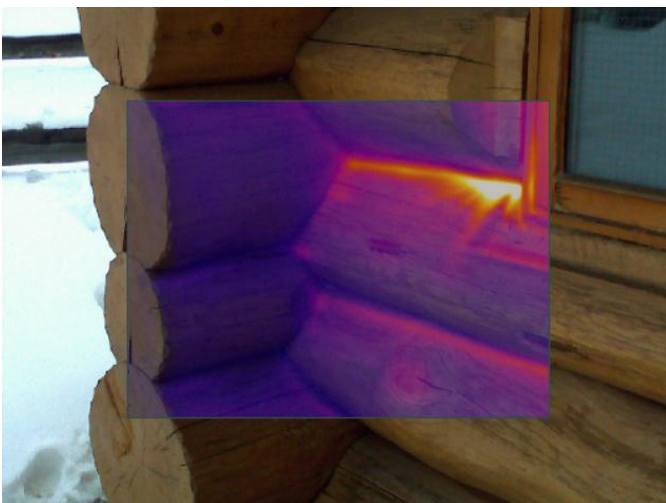
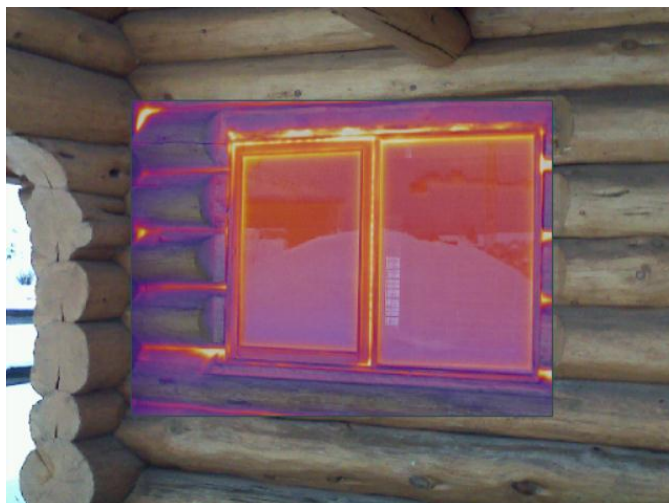
Fig.3.13 Air leakage at windows and joints under pressurization.

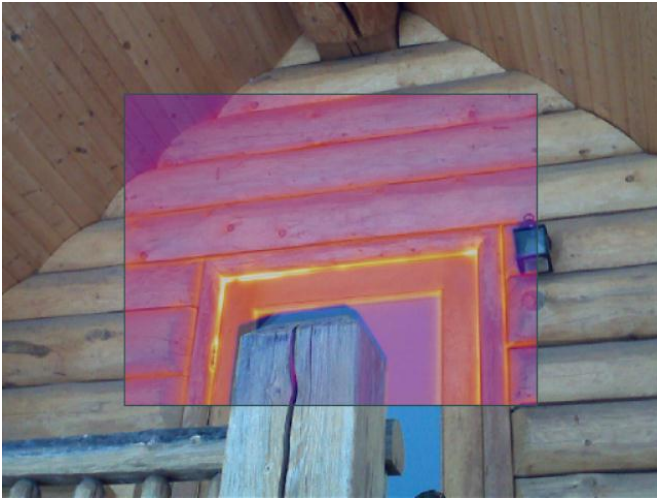
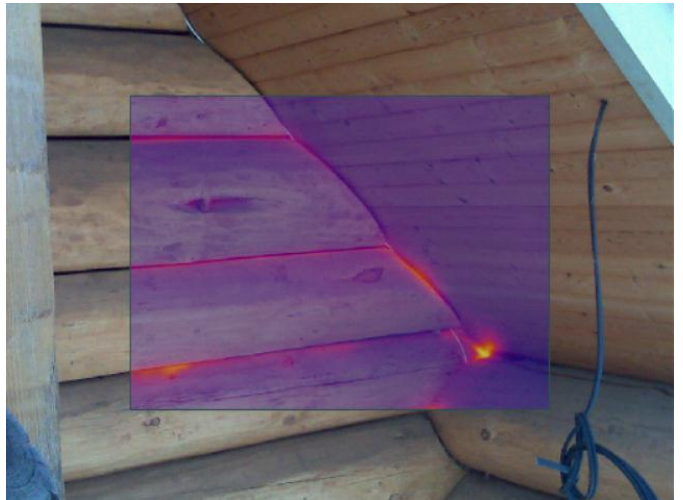
Fig.3.14 Air leakage at second floor door and at roof overhang joints under pressurization.

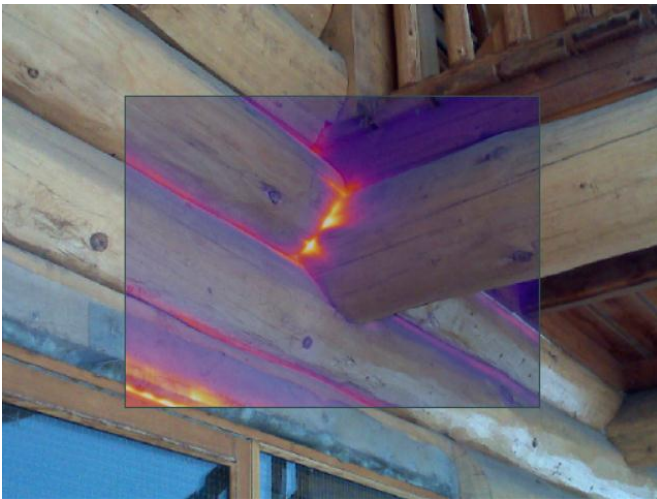
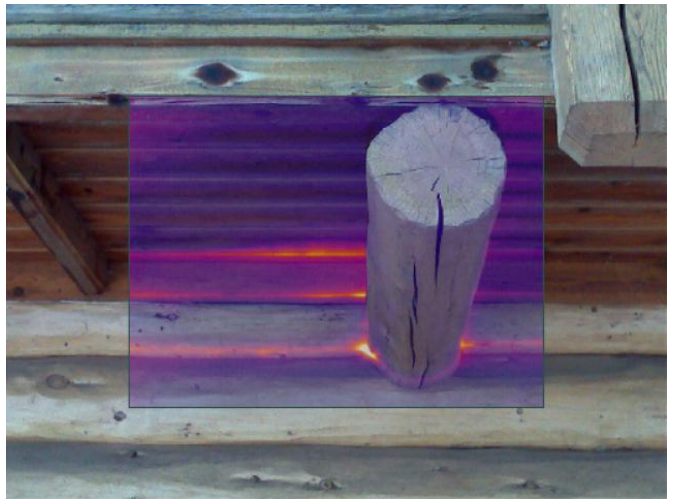
Fig.3.15 Air leakage at joints under pressurization.

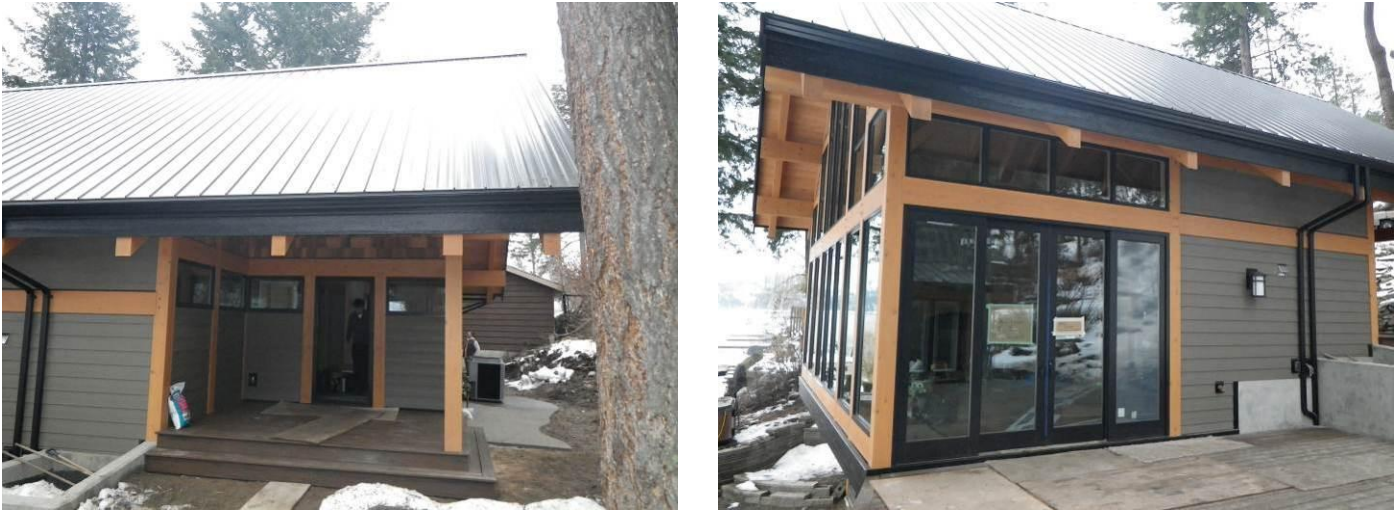
Fig.3.16 Air-tightness test house #3, Chase, BC.

The third test house is a timber frame house with traditional wood stud infill wall construction in Chase, BC (Fig.3.16). The building is new, and at the time of testing interior finishes were being completed. This house is split level, with the main floor (split) plus a loft and a walkout basement, and a cathedral ceiling (Fig.3.17). Heating is provided by a gas furnace and radiant floor heating in the basement. The house has a gas fireplace that was not yet operational.

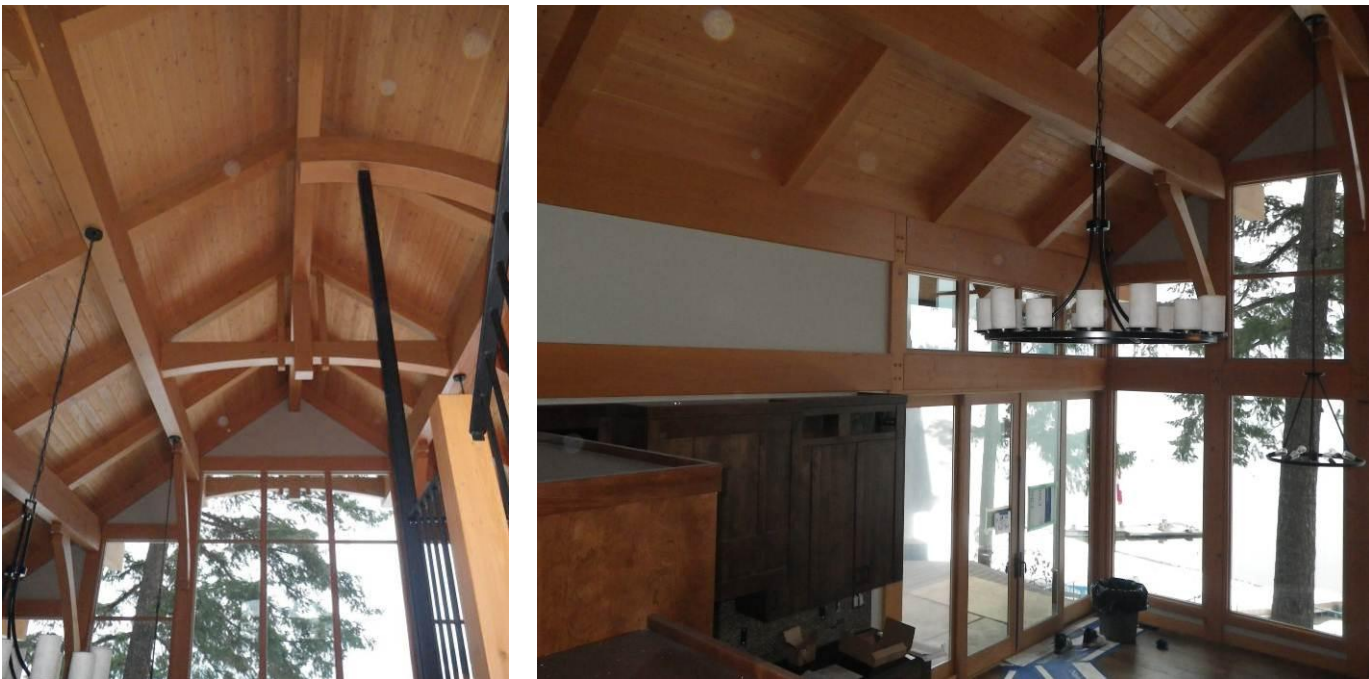
Fig.3.17 Cathedral ceiling and timber frame construction viewed from the inside of test house #3, Chase, BC.

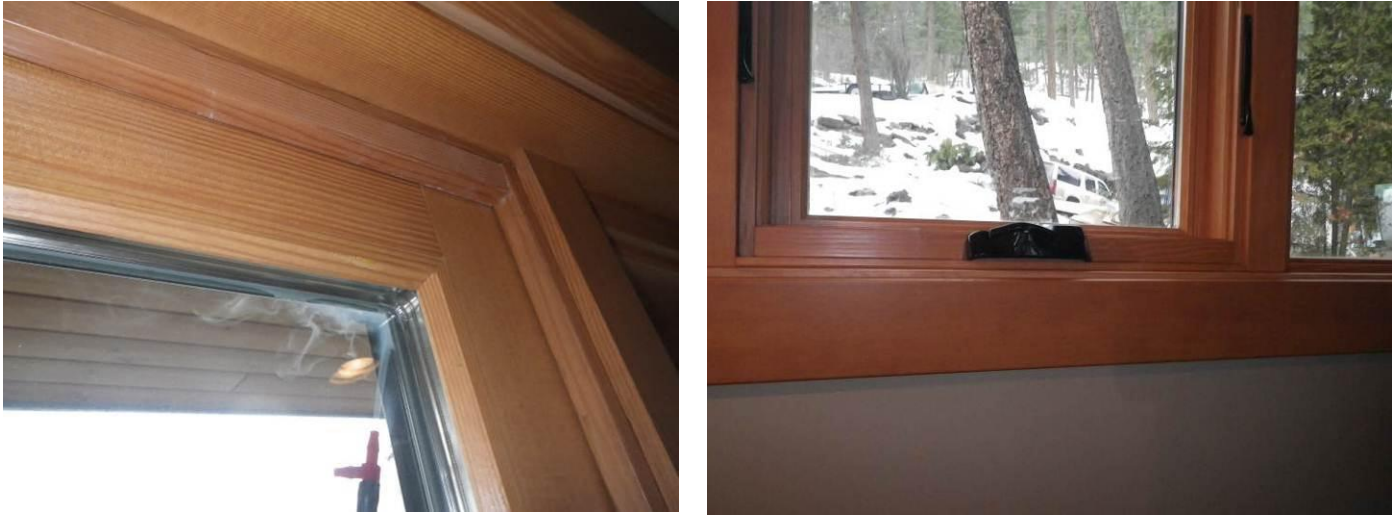
Fig.3.18 Smoke infiltration observed at sliding glass door between IGU and frame (left) and at operable window between sash and frame (right) under depressurization.

Smoke testing using a smoke pencil while the house was depressurized showed air leakage at all of the operable windows, between the sash and the frame. Leakage was also observed at the top right corner of the sliding glass door between the IGU and the frame (Fig.3.18).

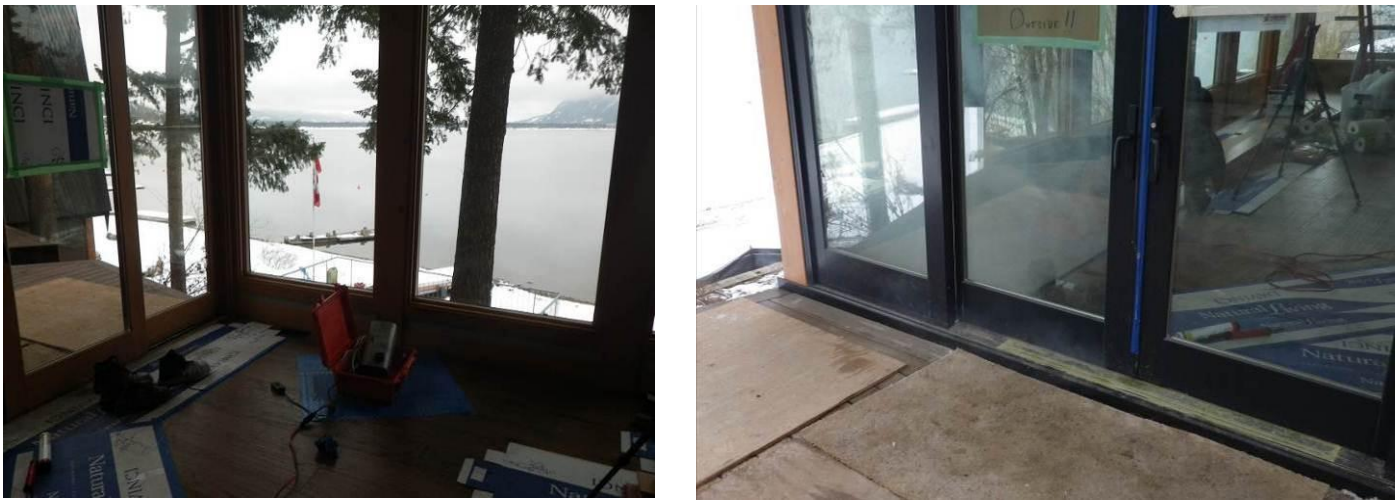
Fig.3.19 Theatrical fog machine used for smoke testing at a corner of the house (left) and smoke leakage observed around the sliding glass door (right) under depressurization.

Smoke testing using a theatrical fog machine while the house was pressurized showed air leakage around the sliding glass door (Fig.3.19). No air leakage was observed at the framing or at fixed windows.

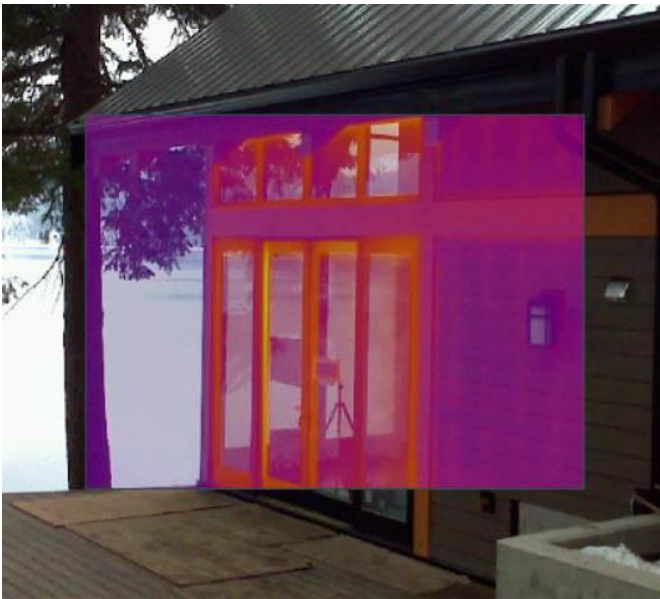
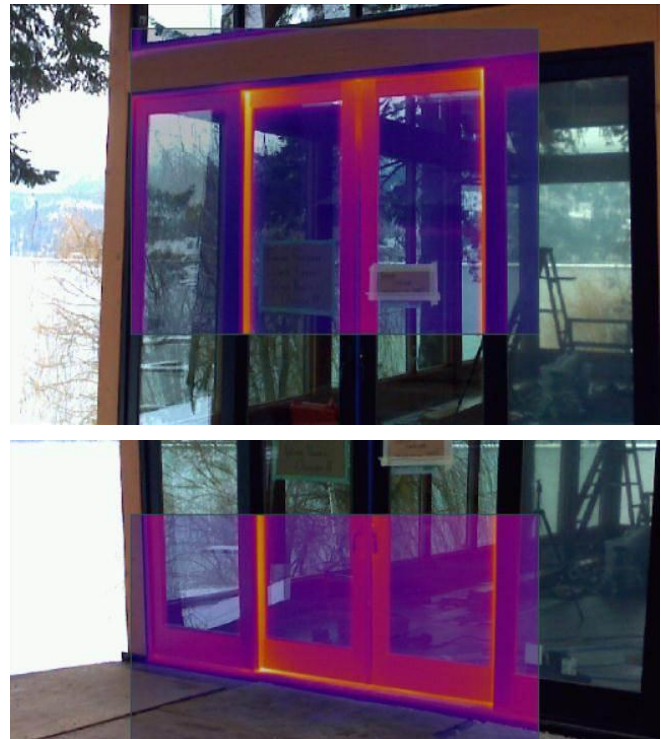
Fig.3.20 IR photo of a sliding glass door during depressurization (left) and pressurization (right), showing air leakage during pressurization around the door frame.

Infrared (IR) thermography photos were taken of the house during depressurization and during pressurization. Fig.3.20, Fig.3.21, Fig.3.22 and Fig.3.23 show IR images during depressurization and pressurization. Fig.3.24 and Fig.3.25 show additional IR images taken during pressurization. The IR images show air leakage occurring at windows, doors, joints, and at the roof to wall interface.

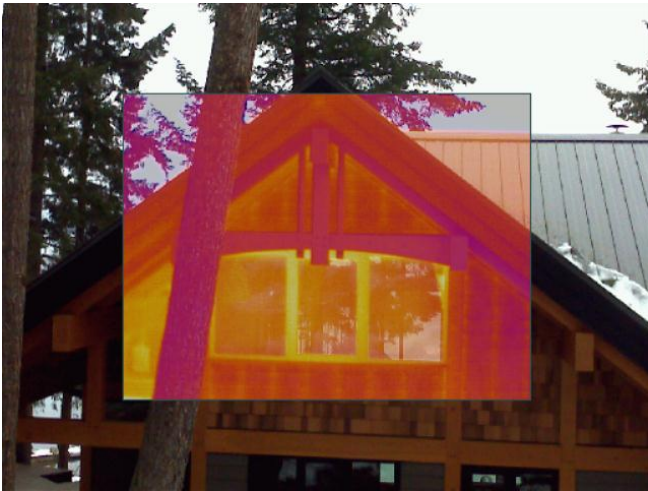
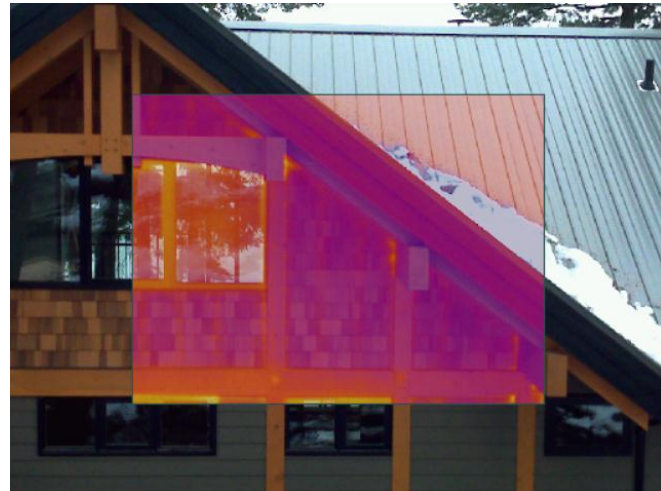
Fig.3.21 IR photo of the gable and roof overhang during depressurization (left) and pressurization (right), showing air leakage at joints during pressurization.

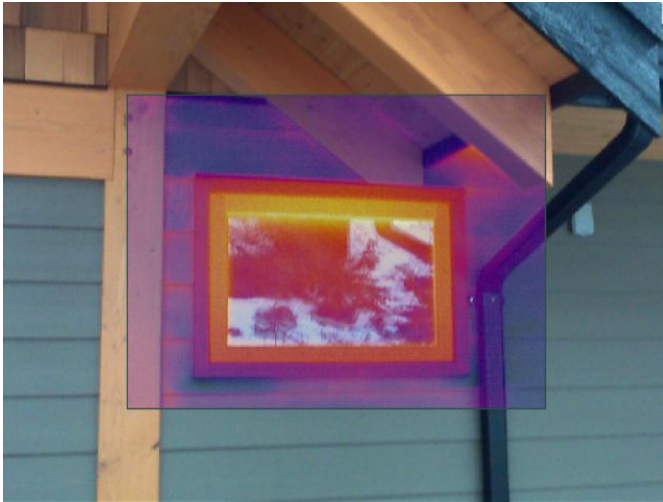
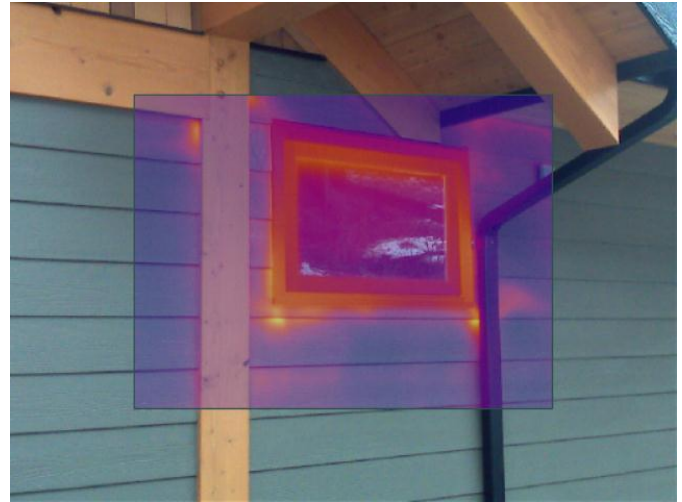
Fig.3.22 IR photo of a window during depressurization (left) and pressurization (right), showing air leakage at the corners during pressurization.

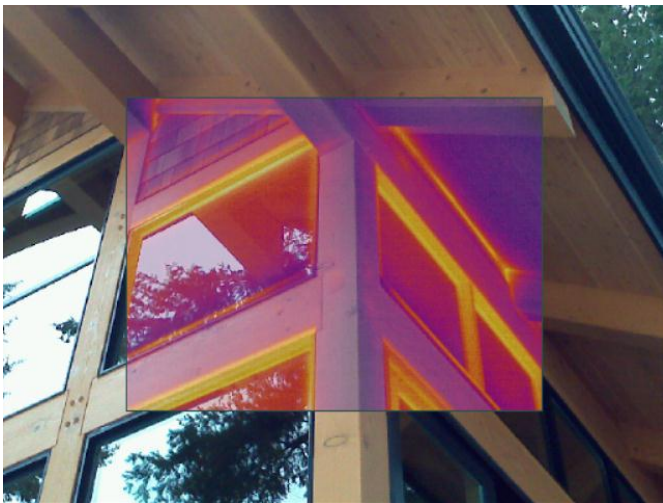
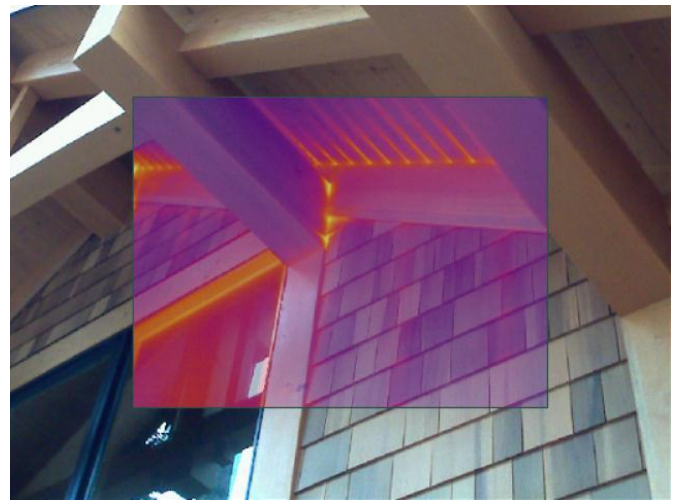
Fig.3.23 IR photo of the roof to wall interface during depressurization (left) and pressurization (right), showing air leakage at this interface during pressurization.

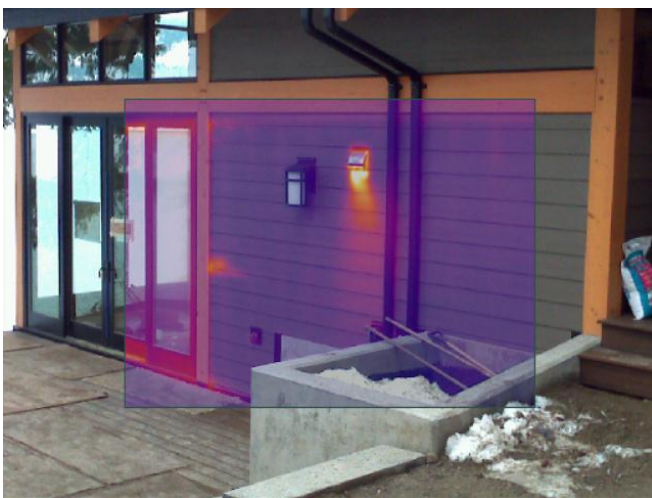
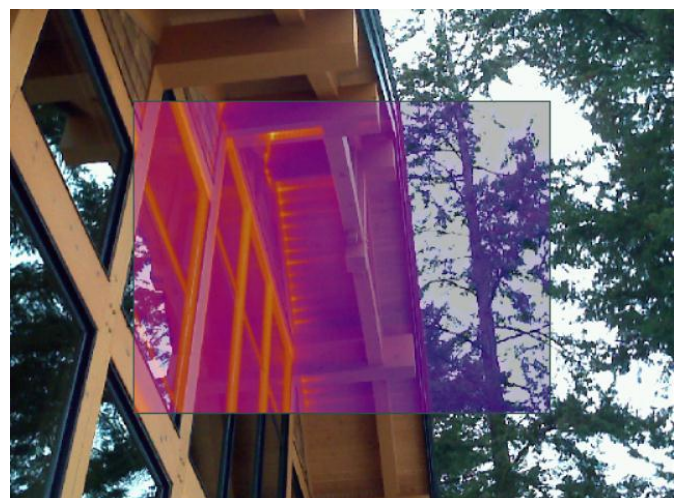
Fig.3.24 Air leakage at a vent (left) and at the roof to wall interface (right), both under pressurization.

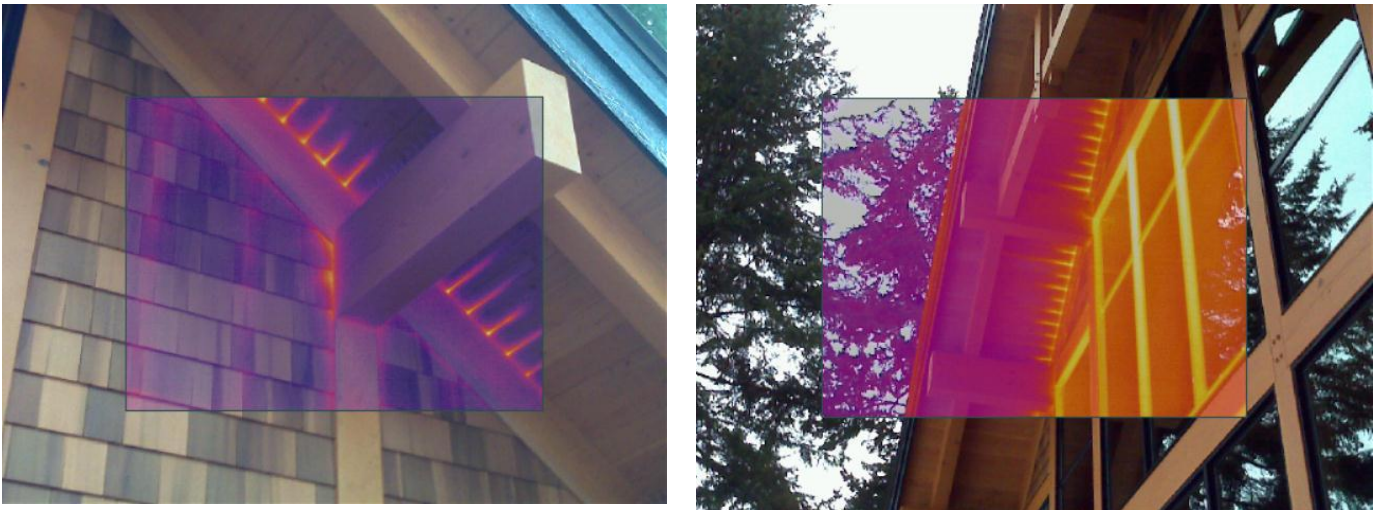
Fig.3.25 Air leakage at the roof to wall interface, both under pressurization.
