# Building Enclosure & Energy Performance of Log & Timber Homes

## Testing and Modeling Summary

PREPARED FOR: BC Log and Timber Frame Home Market Expansion Project

SUBMITTED BY RDH Building Engineering Ltd.  
 224 West 8th Avenue  
 Vancouver, BC V5Y 1N5  
 Canada

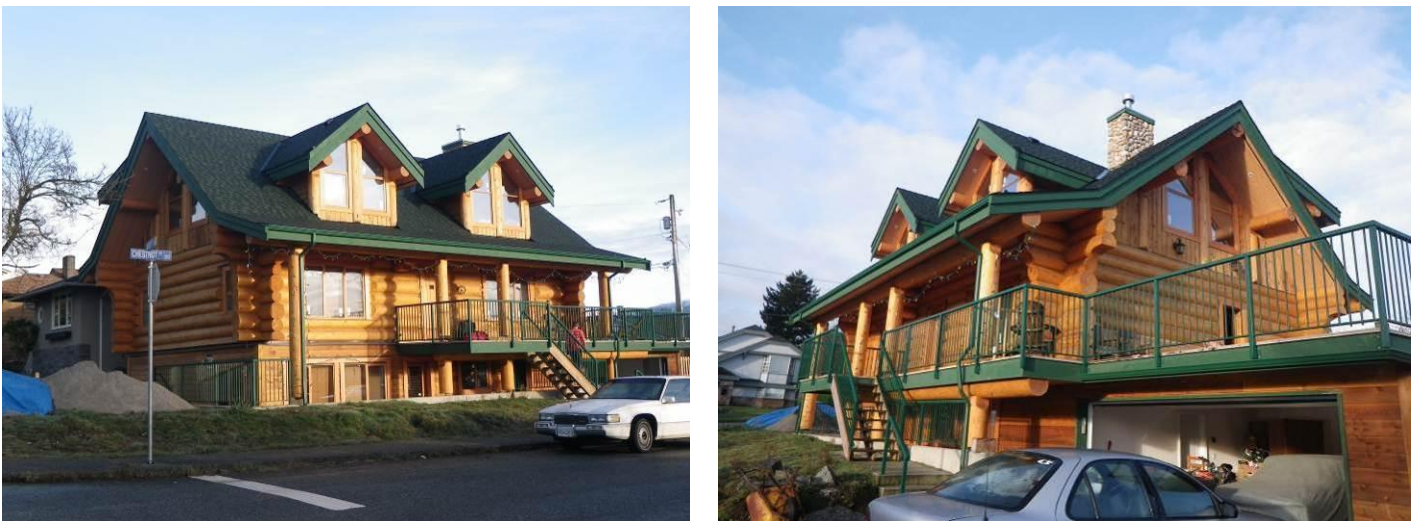
Fig.3.26 Air-tightness test house #4, New Westminster, BC.

The fourth test house is a log home in New Westminster, BC, built in 2011 (Fig.3.26). This house is two-storeys plus a basement, with a cathedral ceiling. Heating is provided by a gas furnace as well as electric baseboards in the basement. The house also has a gas fireplace. The house is made from spruce logs which were measured to have diameters ranging from approximately 13” to 17”. Joints between logs were gasketed.

The area and volume of this house were calculated from floor plans. The floor area of the house is approximately 3,000 sf. The total enclosure surface area (including slab and ceiling areas) is approximately 4,400 sf, and the total volume (including the basement) is approximately 28,400 ft<sup>3</sup>.

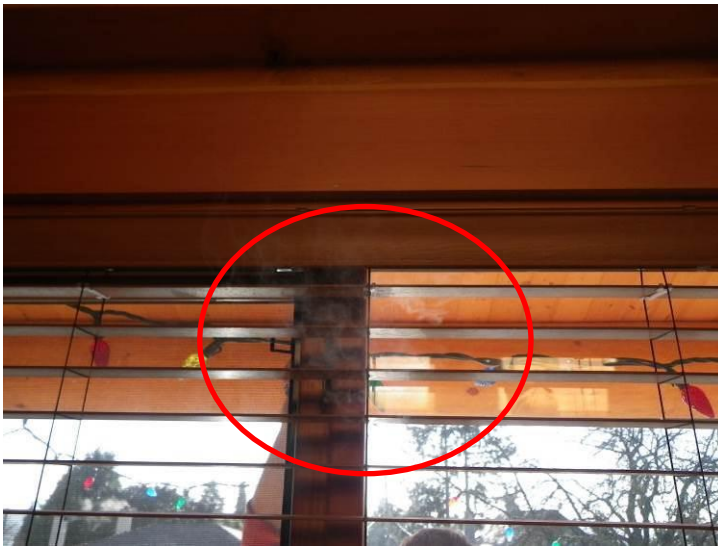
Fig.3.27 Smoke infiltration observed at corner joint during smoke testing from the interior under pressurization.

Smoke testing using a smoke pencil while the house was depressurized showed air leakage at operable windows and at the log wall corner joints (Fig.3.27). At the windows, significant leakage was observed at the operator hardware. Leakage

was also observed at the head and jamb between the frame and the rough opening, and between the sash and the frame of the operable unit.

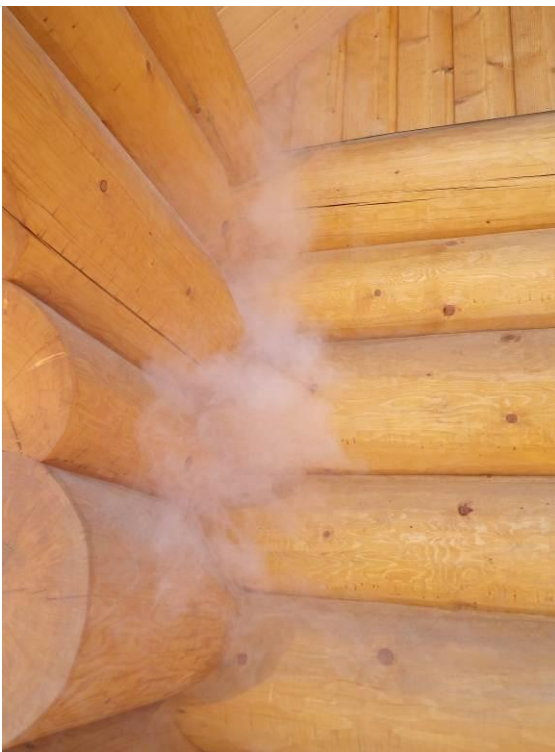
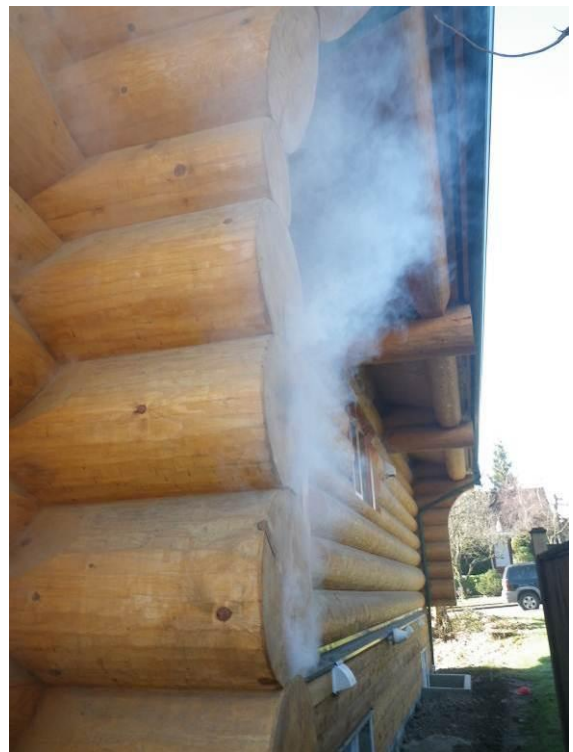
Fig.3.28 Smoke leakage observed at log wall corner joint during pressurization.

Smoke testing was also performed using a theatrical fog machine while the house was pressurized. This testing showed significant leakage at various areas (Fig.3.28, Fig.3.29 and Fig.3.30). Leakage was observed around windows and doors (between the frame and the rough opening), at log wall corner joints, and at the roof soffit.

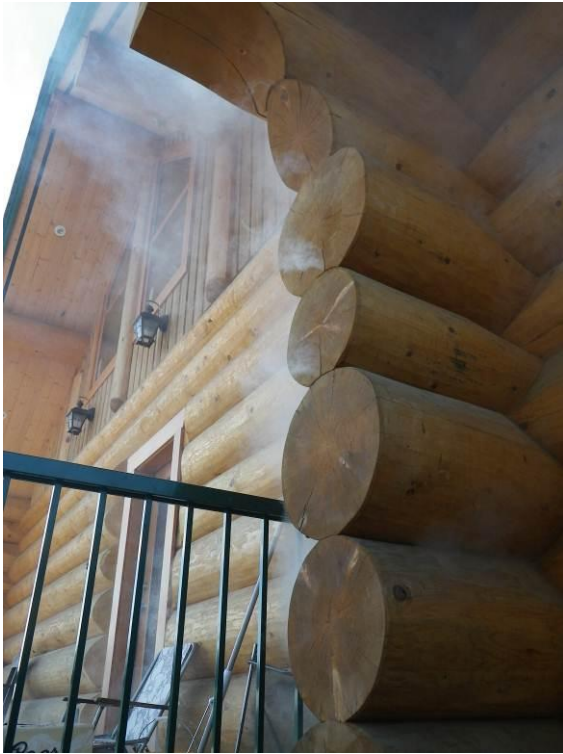
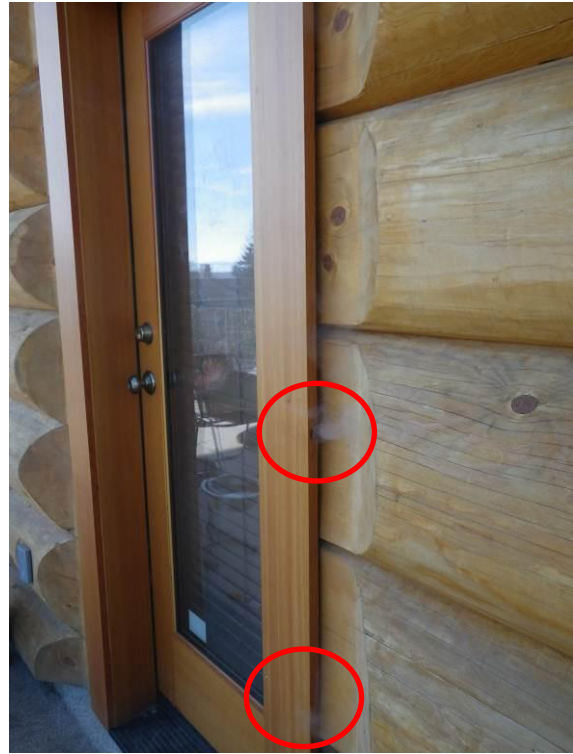
Fig.3.29 Smoke leakage observed at log wall corner joint (left) and at door (right) during pressurization.

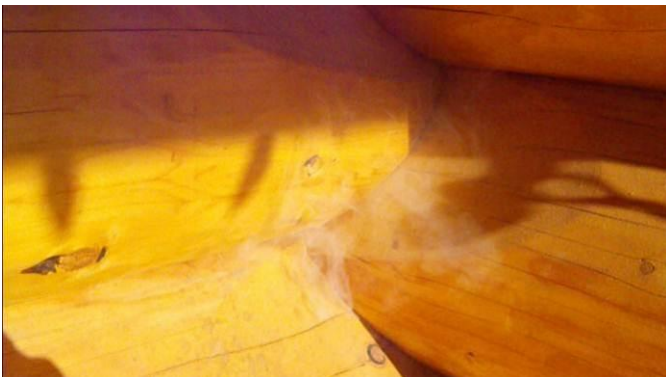
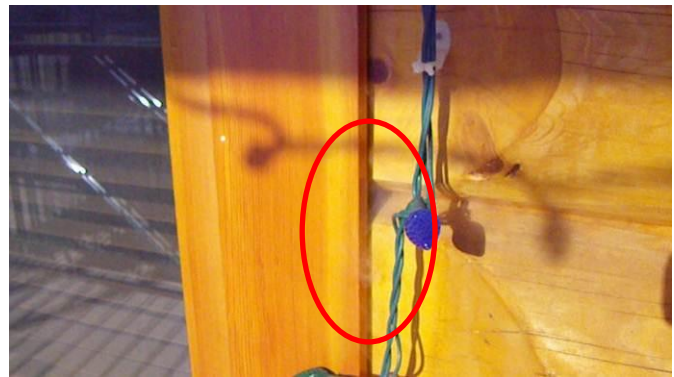
Fig.3.30 Smoke leakage observed at log wall corner joint (left) and at window jamb (right) during pressurization.

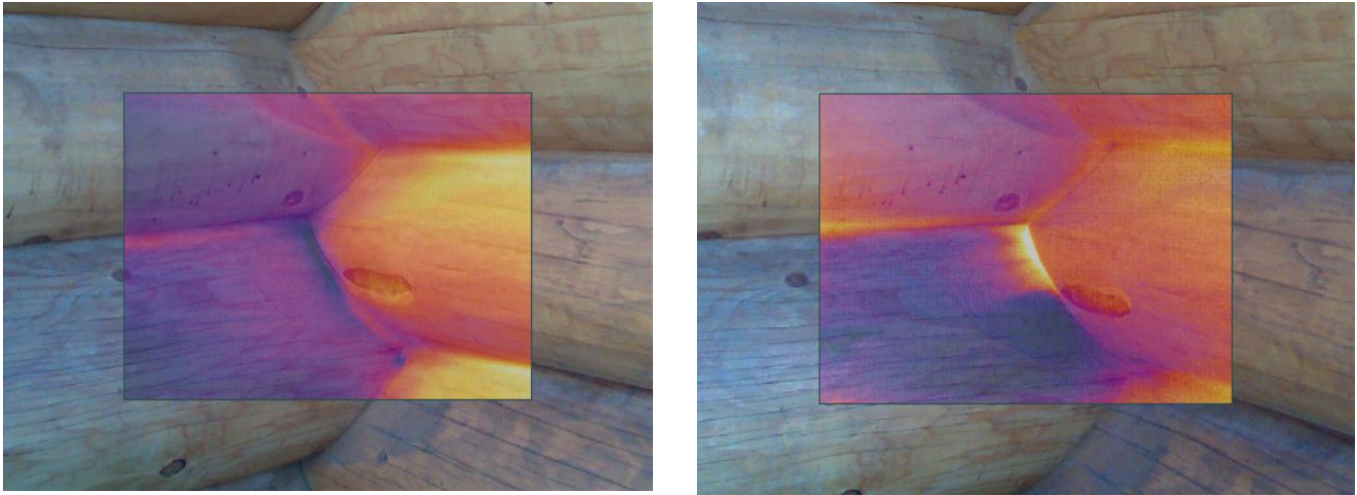
Fig.3.31 IR photo of a log wall corner joint during depressurization (left) and pressurization (right), showing air leakage during pressurization.

Infrared (IR) thermography photos were taken of the house during depressurization and during pressurization; however, air leakage cannot be viewed from many of the images due to sun hitting the building affecting surface temperatures. Fig.3.31 shows IR images during depressurization and pressurization, where air leakage at the joint can be seen during pressurization.

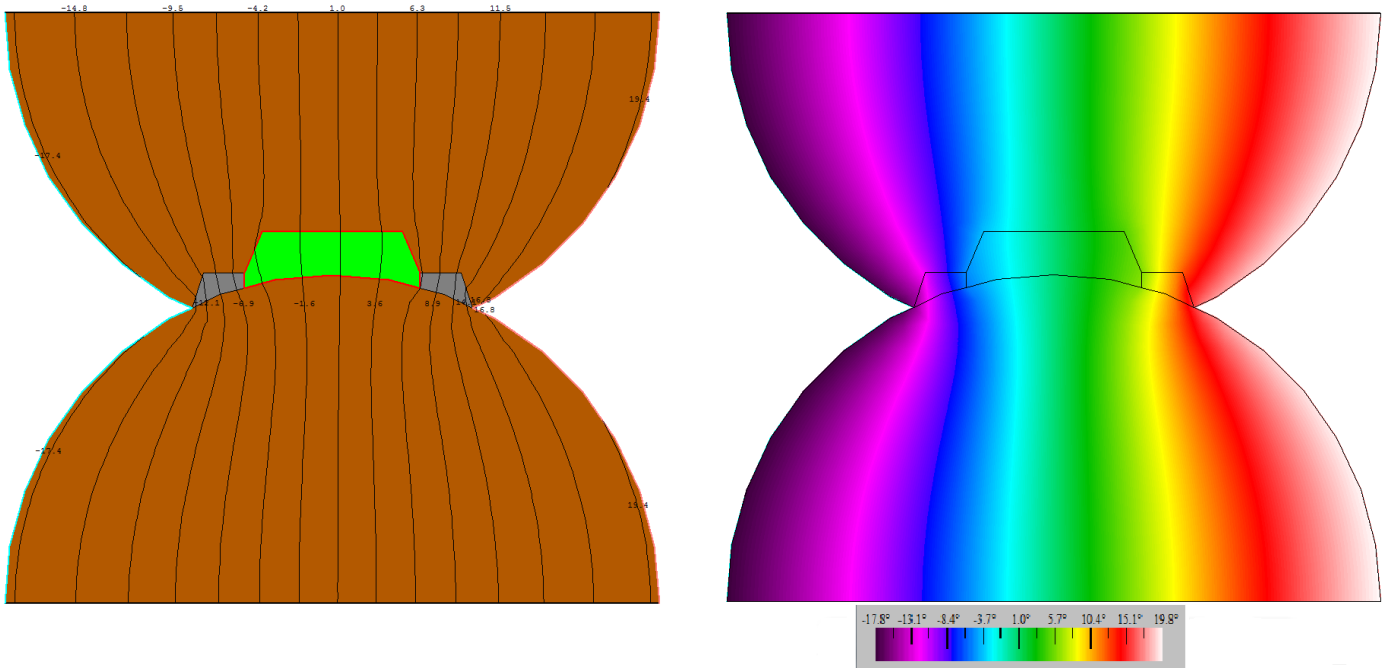
Fig.4.1 THERM simulation of log wall with foam gasket and air space.

THERM simulations were completed for two wood species and four log sizes. The wood species Douglas Fir and Western Red Cedar were chosen since they represent a low and high R-value per inch wood species, respectively. A log diameter of 14" is typical based on discussions with BC log home builders, and therefore log diameters of 10", 14", and 18" were simulated for comparison. Each wall was simulated with a typical foam gasket joint and with an air space for comparison. Joint thicknesses were assumed to be 4", 5" and 6" for the 10", 14" and 18" diameter logs, respectively. The ICC 400-2012 inside and outside air film values were used in the THERM simulations. Fig.4.1 shows a sample log wall THERM simulation.

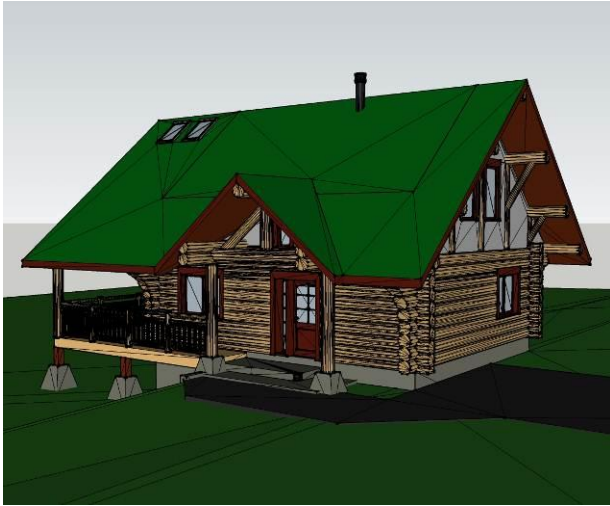
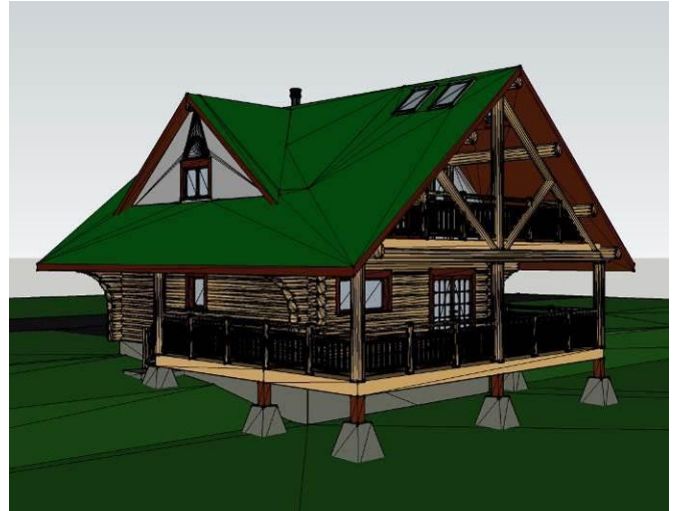
Fig.4.2 Archetype 1 front view (left) and back view (right).

The first archetype is a two-storey log home with a floor area of approximately 1,200 sf (Fig.4.2 and Fig.4.3). The house has a cathedral ceiling and does not have a basement. The overall window to wall ratio of the house is 15% (including glazed doors). The first floor exterior walls are constructed from logs, and the second floor gable areas are assumed to be typical wood frame construction. The house also has second floor knee walls that are assumed to be framed construction.

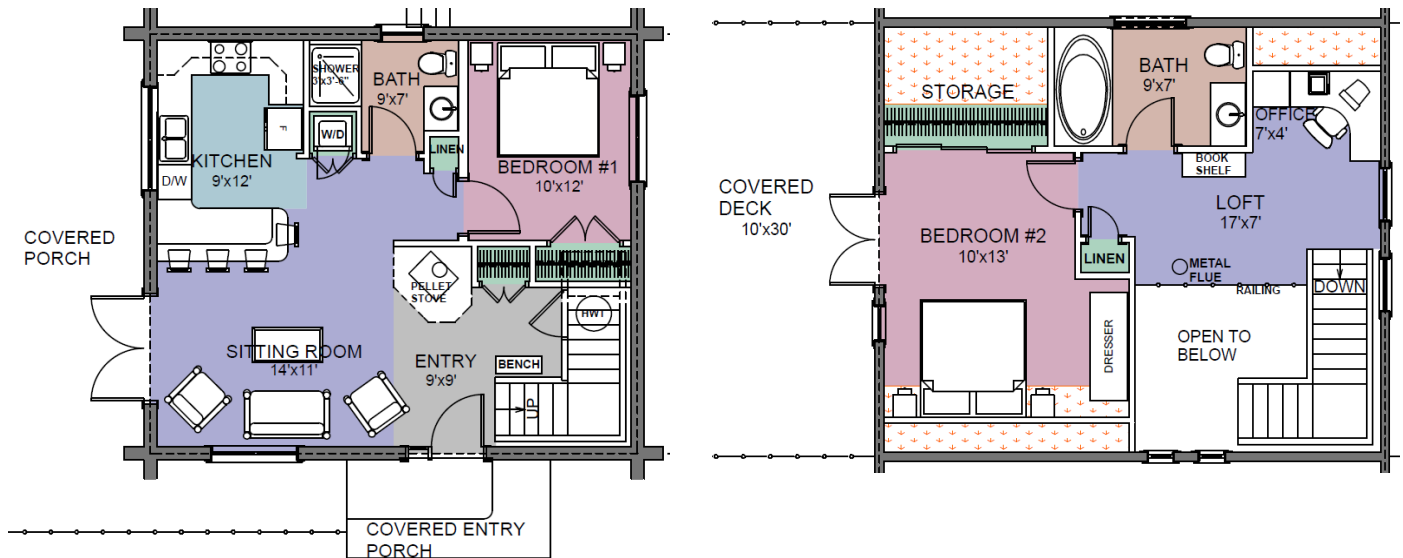
Fig.4.3 Archetype 1 first floor plan (left) and second floor plan (right).

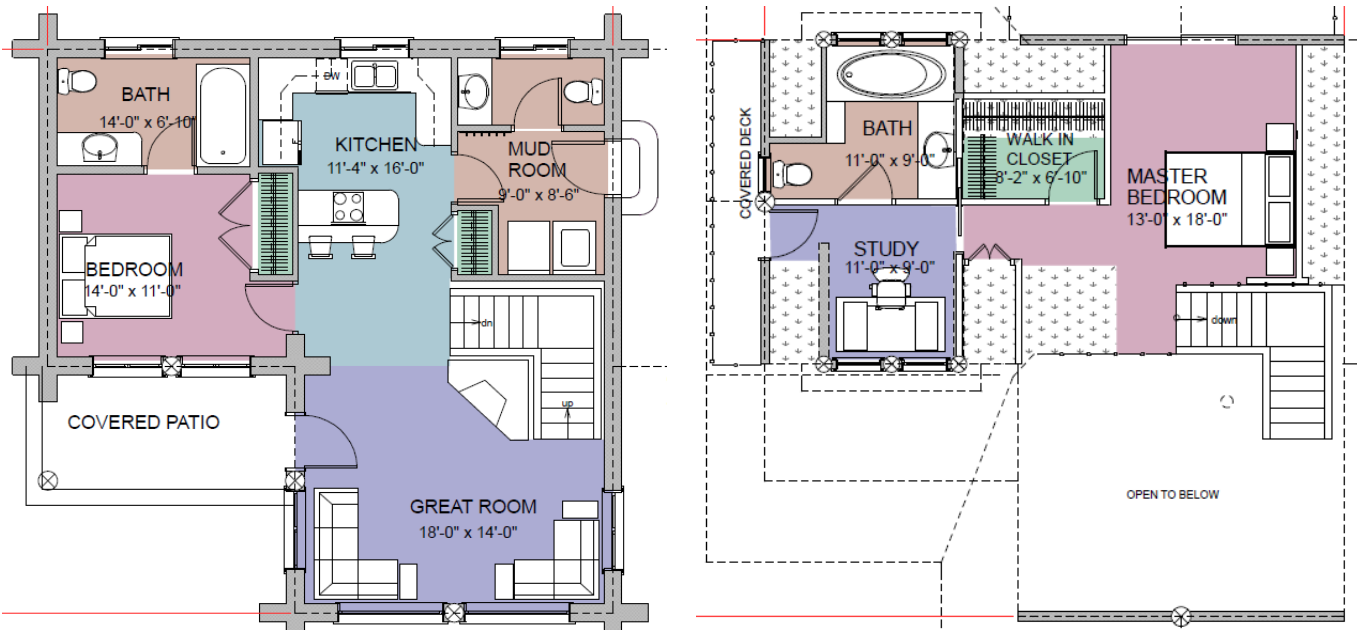
Fig.4.5 Archetype 2 first floor plan (left) and second floor plan (right).

The second archetype is a two-storey log home with an above grade floor area of approximately 1,200 sf (Fig.4.4 and Fig.4.5). The house has a cathedral ceiling and a basement. The overall window to wall ratio of the house is 18% (including glazed doors). The first floor exterior walls are constructed from logs, and the second floor gable areas are assumed to be typical wood frame construction. The house also has second floor knee walls that are assumed to be framed construction.

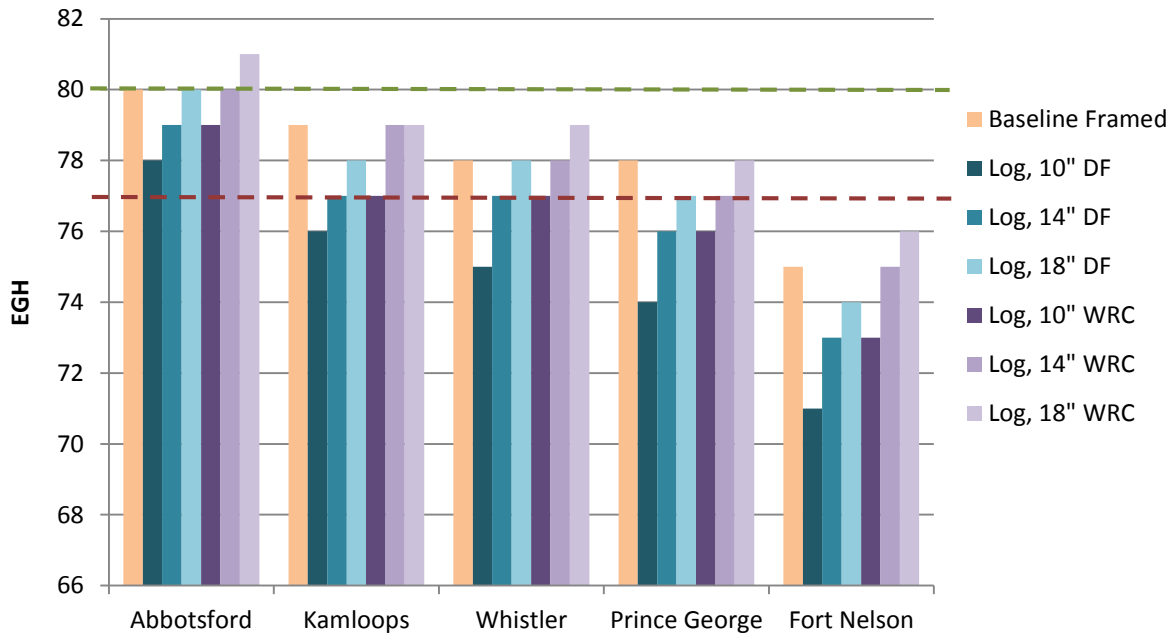
Fig.4.6 Energy simulation results for baseline framed and log homes, Archetype 1.

The baseline framed house achieves EGH-80 in Abbotsford, EGH-79 in Kamloops, EGH-78 in Whistler and Prince George, and EGH-75 in Fort Nelson. The log homes are generally lower than the framed house due to the lower R-value of log walls, with the exception of 18” Western Red Cedar walls, which have a slightly higher R-value than the framed 2x6 walls with batt insulation. These results show that large logs of the highest R-value wood species would be required to meet current code with no other energy upgrades, however with future code changes to increase the energy efficiency of homes (i.e. as the framed wall insulation requirements increase), these houses will not likely meet code. EEMs are required to meet code through energy modeling or the EnerGuide rating system.

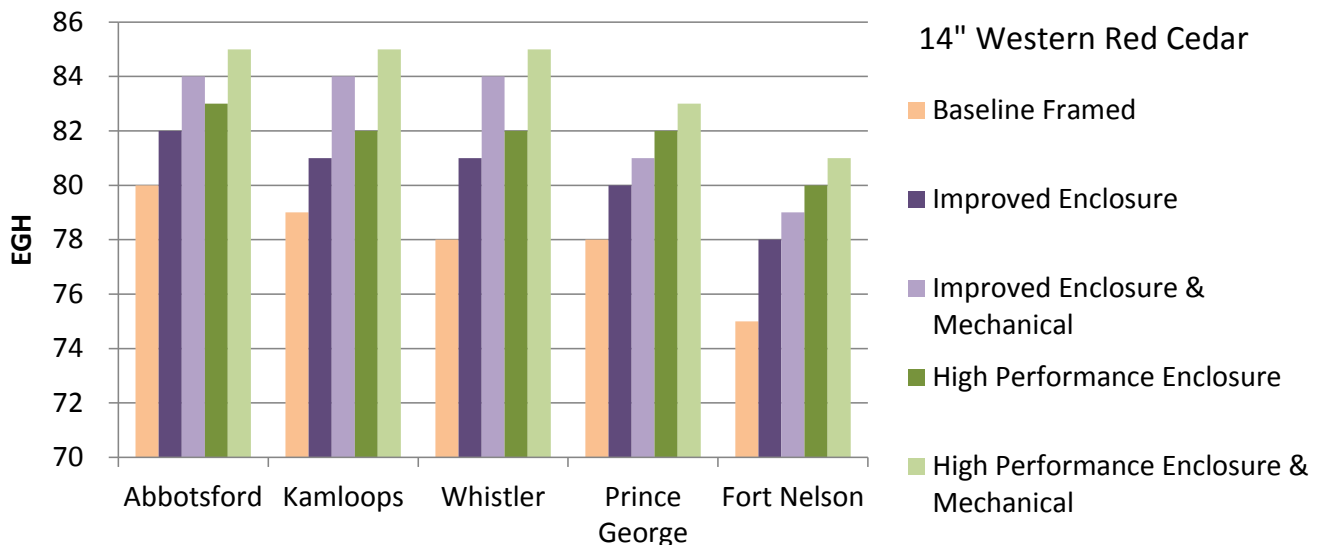
Fig.4.10 Energy simulation results for groups of EEMs with 14” Western Red Cedar log walls, Archetype 1.

In the colder climates of Prince George and Fort Nelson, the enclosure only changes result in EGH ratings of 76 to 80, while the enclosure and mechanical improvements result in EGH ratings of 78 to 81. These changes do not all meet the current EGH-77 and future EGH-80 target, however they result in much better energy performance than the baseline framed house and would therefore meet current code under the energy modeling path.

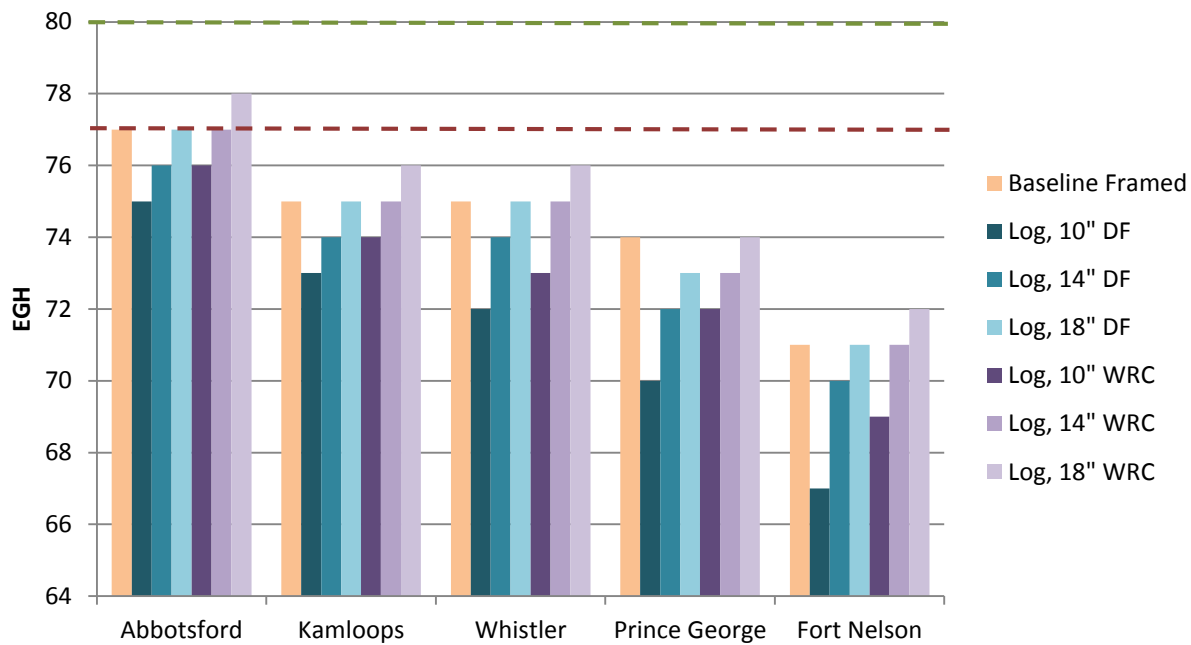
Fig.4.11 Energy simulation results for baseline framed and log homes, Archetype 2.

The energy simulation results show that large logs of the highest R-value wood species would be required to meet current code with no other energy upgrades, however with future code changes to increase the energy efficiency of homes (i.e. as the framed wall insulation requirements increase), these houses would not likely meet code. EEMs are required to meet code through energy modeling or the EnerGuide rating system.

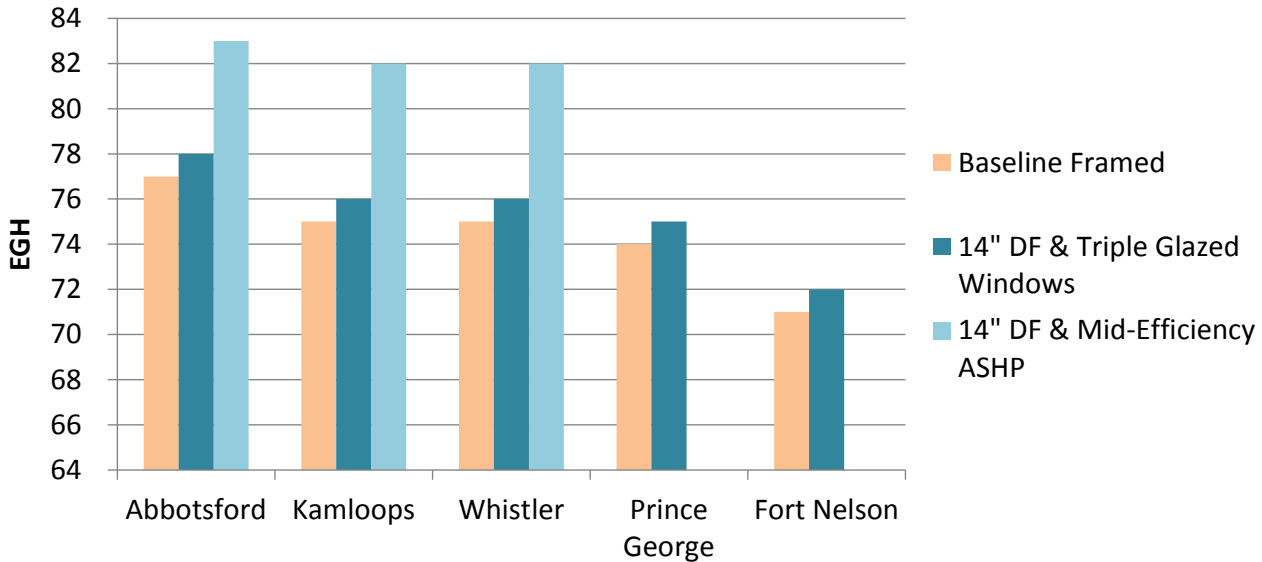
Fig.4.12 Energy simulation results for baseline framed house and 14” Douglas Fir log house with EEMs, Archetype 2.

The simulation results for the individual EEMs show that triple glazed windows or ASHP heating systems alone can achieve compliance with the 2012 BCBC. Other individual EEMs do not have a big enough impact alone to achieve significant energy savings.

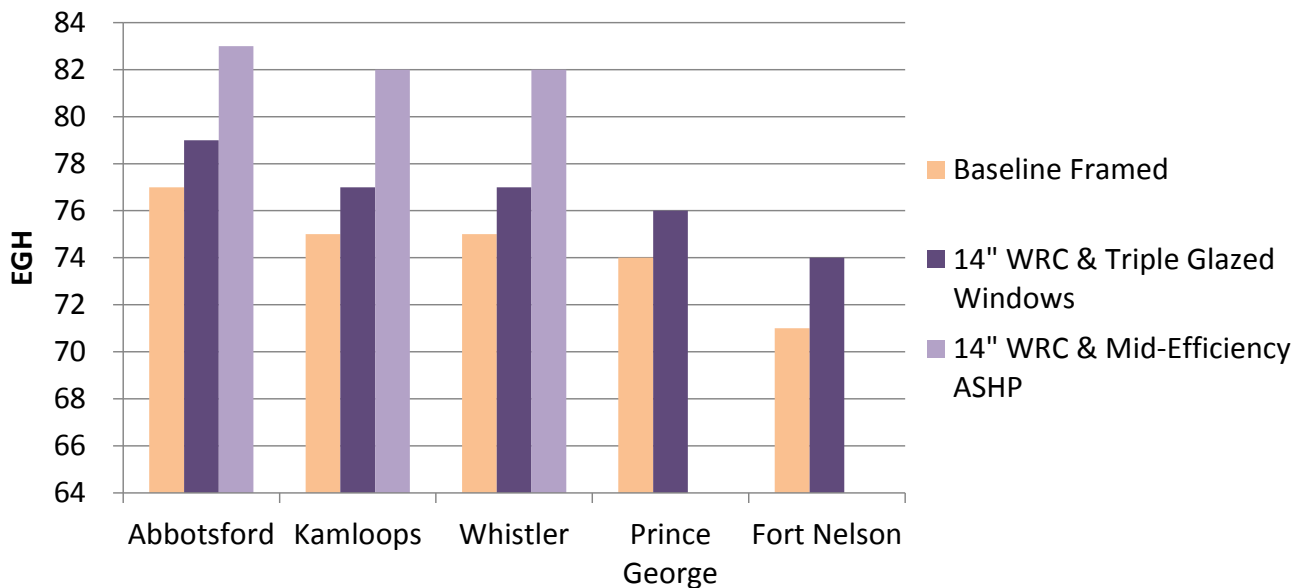
Fig.4.13 Energy simulation results for baseline framed house and 14” Western Red Cedar log house with EEMs, Archetype 2.

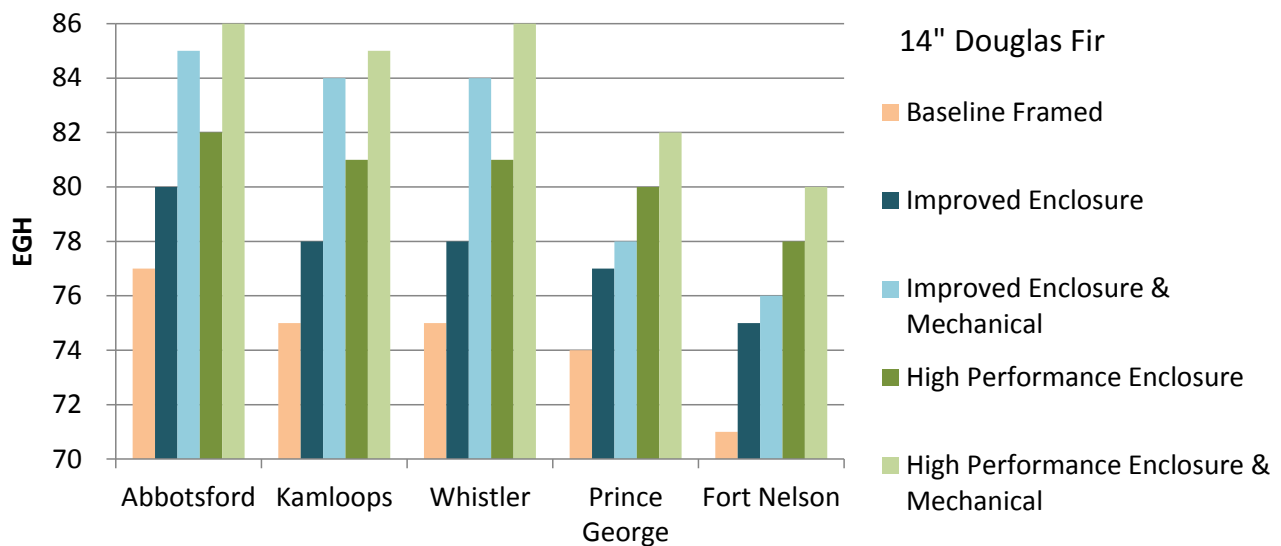
Fig.4.14 Energy simulation results for groups of EEMs with 14” Douglas Fir log walls, Archetype 2.

In the colder climates of Prince George and Fort Nelson, the enclosure only changes result in EGH ratings of 75 to 81, while the enclosure and mechanical improvements result in EGH ratings of 76 to 83. These changes do not all meet the current EGH-77 and future EGH-80 target, however they result in much better energy performance than the baseline framed house and would therefore meet current code under the energy modeling path.

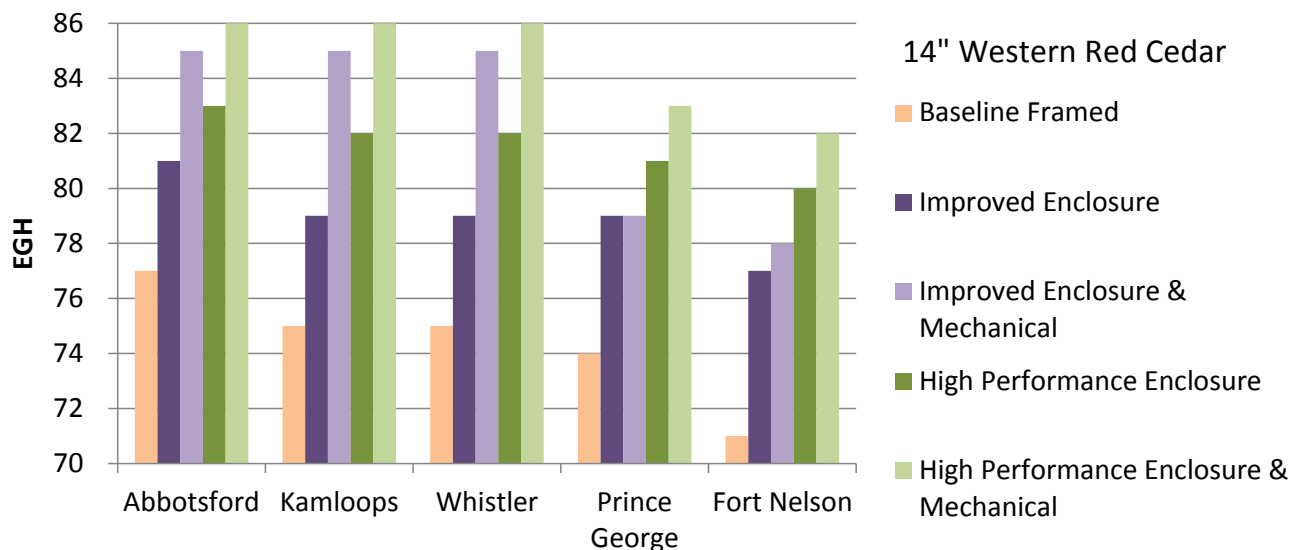
Fig.4.15 Energy simulation results for groups of EEMs with 14” Western Red Cedar log walls, Archetype 2.

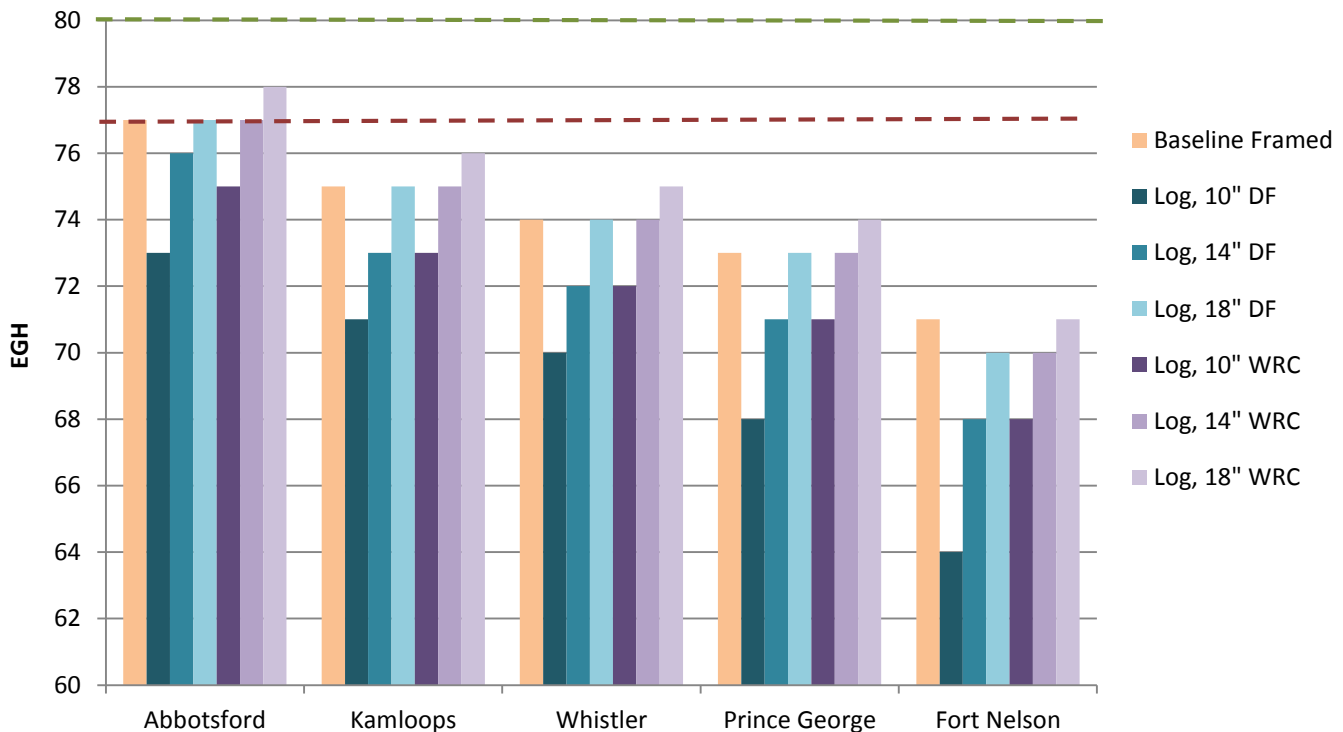
Fig.4.16 Energy simulation results for baseline framed and log homes, Archetype 3.

The energy simulation results show that large logs of the highest R-value wood species would be required to meet current code with no other energy upgrades, however with future code changes to increase the energy efficiency of homes (i.e. as the framed wall insulation requirements increase), these houses would not likely meet code. EEMs are required to meet code through energy modeling or the EnerGuide rating system.

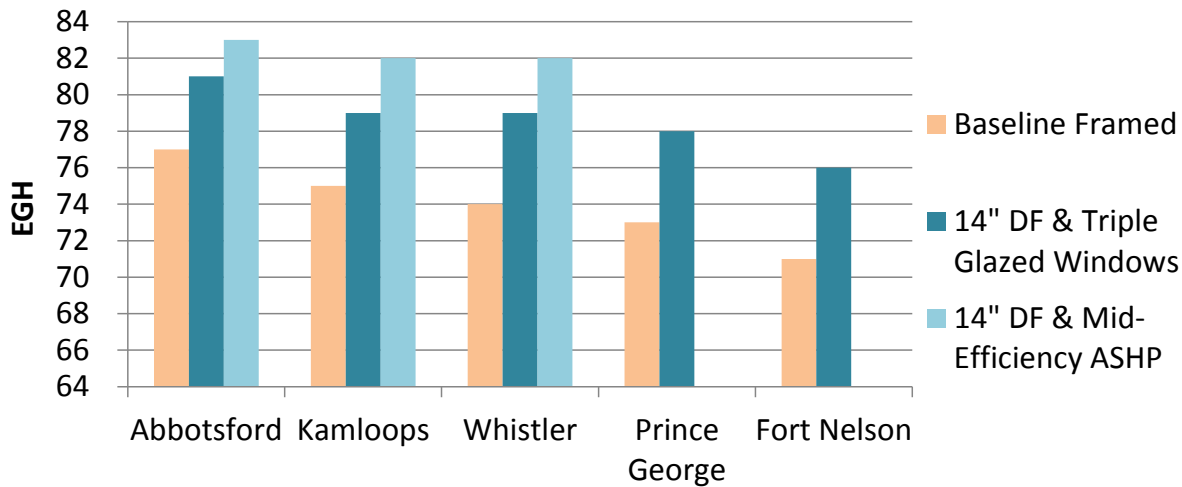
Fig.4.17 Energy simulation results for baseline framed house and 14” Douglas Fir log house with EEMs, Archetype 3.

The simulation results for the individual EEMs show that triple glazed windows or ASHP heating systems alone can achieve compliance with the 2012 BCBC.

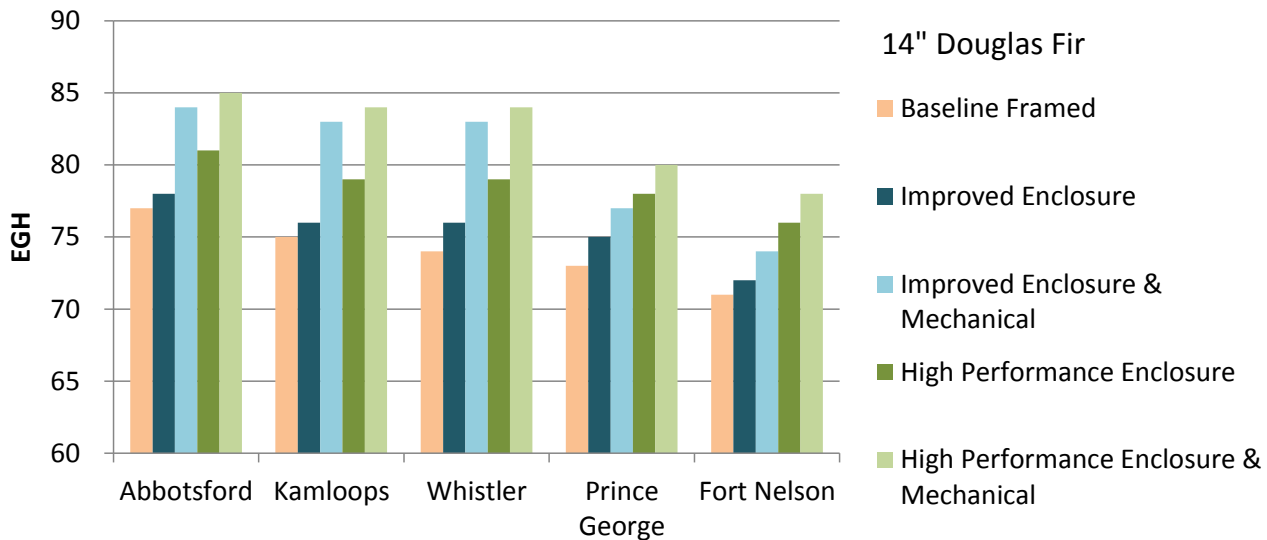
Fig.4.19 Energy simulation results for groups of EEMs with 14" Douglas Fir log walls, Archetype 3.

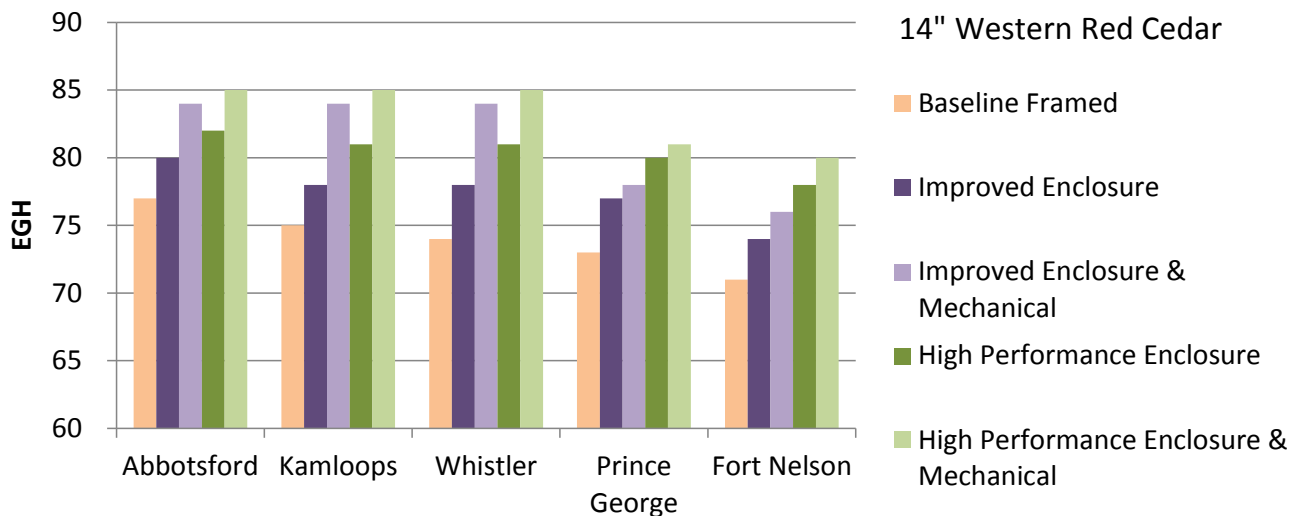
Fig.4.20 Energy simulation results for groups of EEMs with 14" Western Red Cedar log walls, Archetype 3.
